Safety Flash 21/20

July 2020

1 Double Man Overboard Resulting in one Fatality

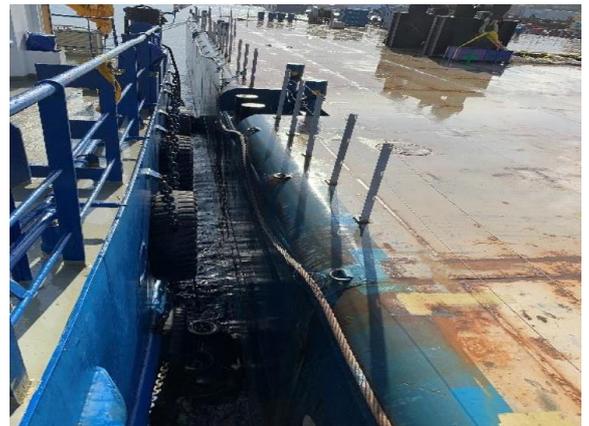
During preparations for disconnecting a tow tug which was moored to a barge in turn moored to the jetty, a crew member of the tow tug fell into water between the tow tug and the barge. A second crew member also fell into the water during attempts to rescue his colleague.

Following a worsening of the weather, it was decided to disconnect the tow tug from the barge. The Chief Mate stepped over to the barge to check certain equipment, but found that he needed a torch to do so. He called for a torch by radio. An AB collected a torch and made his way to deck where the 2nd Mate was acting as safety watch for the Chief Mate. The AB handed over his radio to the 2nd Mate, who did not have a radio. Whilst the 2nd Mate was occupied with the radio, he took his eye off the AB who, at this point, fell into the water. When the 2nd Mate realised what had happened he shouted "Man Over Board" and attempted to rescue the AB. During his attempts he also fell into the water. In the meantime the MOB alarm was raised and all hands were on deck. The 2nd Mate was helped out of the water. The AB was still in the water and had now lost consciousness. After a number of attempts he was pulled towards the rescue zone door by a boat hook, where he was manually lifted out of the water. The 2nd Mate was treated for hypothermia. The AB was administered CPR and AED by the crew until medical assistance arrived. The AB was medevaced by helicopter but did not survive.

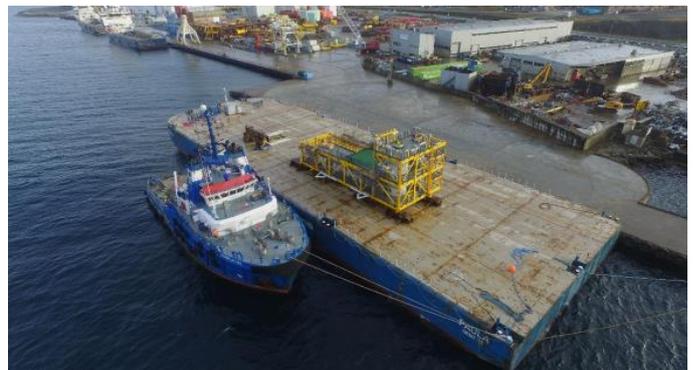
- ◆ Vessel to vessel transfer was accepted and regarded as a routine activity;
- ◆ Risk awareness did not deal with specific risks of routine activities in non-routine circumstances. The focus is on what has to be done, not on how/risks involved;
- ◆ MOB between two stationary vessels was not specifically addressed in procedures, risk assessments or drills related to MOB. Rescue equipment was not primarily suitable for rescuing MOB from between two vessels.

Our member notes that both the AB and the 2nd Mate were wearing inflatable lifejackets which slipped up their heads whilst they were in the water.

- ◆ Procedures, risk assessment and toolbox talks:
 - Review procedures with regard to direct vessel to vessel personnel transfer;
 - Include the risk of hypothermia in procedures and risk assessments related to falling in the water;

- Review MOB procedures and drills to include MOB situations between two stationary vessels/between vessel and quayside;
 - Ensure that toolbox talks not only deal with what has to be done, but also with how it should be done and the specific situational risks involved, including changes in operating conditions. Ensure that when work cannot be carried out safely anymore, the **Stop Work authority** is applied.

- Properly assess additional risks of carrying out **routine activities under non-routine conditions**;
- ◆ Equipment
 - Ensure that heaving line and bag are applied for transfer of equipment/tools (such as a torch in this case) from vessel to vessel;

- Ensure that the required equipment/tools are defined prior to carrying out a non-routine job;
 - Review MOB equipment and techniques used for rescue in limited situations, for example between two stationary vessels or between vessel and quayside;

- Consider introducing life jackets with crotch straps.
