Safety Flash 22/20

1 Finger injury caused by incorrectly secured console cover

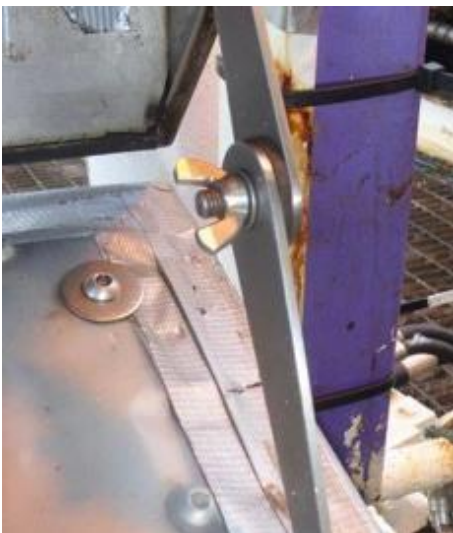
Hinged mechanism was retained by two unsecured wing nuts

- ❑ The hinge was found to function correctly, as designed, but the wing nuts that secured the hinge in place had not been sufficiently tightened;
- ❑ The console cover, possibly affected by weather or vessel movement, dropped at the same moment the injured persons finger was placed in the line of fire;
- ❑ The design of the console weather cover hinge was completely reliant on correct wing nut tightening and requires an improved means of securing to avoid similar cover displacements;
- ❑ Hinge mechanisms that do not lock automatically or "lock-safe", introduce the risk of injury from unintentional or unexpected closing of the covers.

- Carry out a “Hazard Hunt” on your vessel to identify all hinged cover mechanisms that have the potential for repeating the incident outlined in this alert;
- Install improved hinge locking arrangements wherever a significant risk of hand or finger injury is identified.

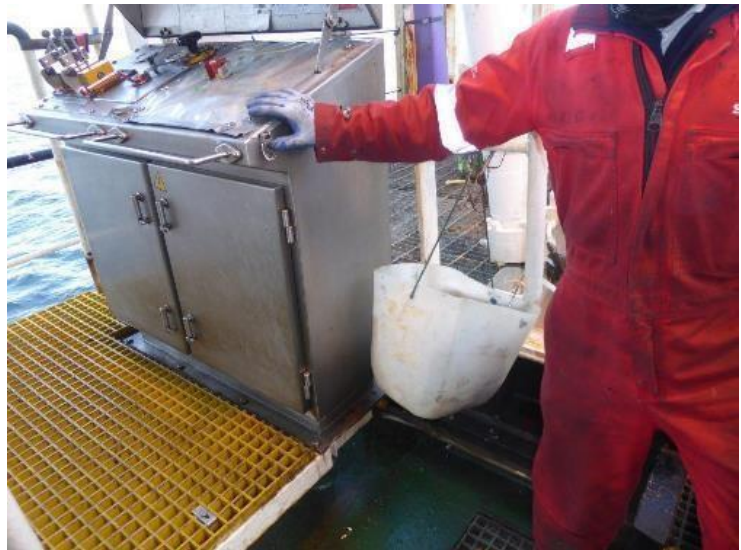
An incorrectly secured console cover closed in an unplanned and unexpected way, trapping a crew member's finger, which was injured. After completing a task on a raised working platform a technician was coming down the steps back down to the deck level. To steady his descent, he placed his hand on the corner of a control console. The console cover dropped unexpectedly to its closed position trapping his smallest finger on his right hand between the console and the edge of the cover. This guillotine action fractured his finger.

The injured person had been descending the raised platform and placed his hand on the console to steady his descent
