DESCRIPTION

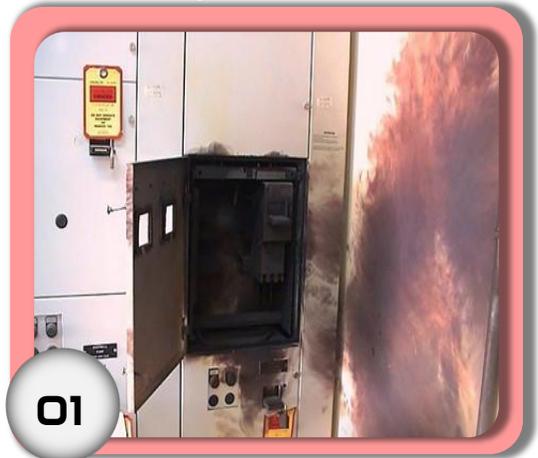
A crewman was doing electrical work on a 440v power distribution panel (PDP), when a loose earth bonding cable contacted a live 440v bus bar causing a short circuit and an arc flash. Whilst the crewman was using cable ties to fix loose cables within the panel, he observed a loose earth bonding cable in poor condition. He made up a new earth cable from 6mm wire, and whilst he was attempting to re-connect the earth bonding cable, the loose trailing end of the earth bonding cable met the 440Vac bus bar. A short circuit between the 440Vac and the Earth bonding cable was observed resulting in an arc flash.

- Crew deliberately ignored safety protocols to expedite what was considered an easy and straightforward task:
 - one job was started (supervising the installation of a welding cable) but then changed to another job. The injured person did not discuss this work with his supervisor, nor carry out a risk assessment, TBT or raise a PTW for the work
 - there had been a generic toolbox talk (TBT) completed but work on the PDP was not mentioned;
- This incident was not reported in a correct or timely way, denying the injured person access to immediate medical attention which may have mitigated his injuries.

- All There was inadequate supervision with regards to compliance with electrical safety control measures;
- The risk of unauthorised access to the power distribution panel (PDP) had not been properly assessed;
- The panel had inadequate insulation of terminals which remained live when panel was opened, this may have been broken off or removed over time.
- Access to electrical cabinets should be restricted;
- Electrical safety audit conducted on-board vessel;
- Risk assessment to be re-written to include mitigations to identified hazards;
- Further incident reporting and investigation training to be delivered to vessel crew.
