# National Transportation Safety Board

## Marine Accident Brief

### Overtuning of the Liftboat *Kristin Faye*

<b>Accident type</b>	Other	<b>No.</b> DCA19FM050
<b>Vessel name</b>	<i>Kristin Faye</i>	
<b>Location</b>	Gulf of Mexico, Main Pass Block 64, about 18 miles east of Venice, Louisiana 29°18.10' N, 89°03.30 W	
<b>Date</b>	September 8, 2019	
<b>Time</b>	1015 central daylight time (coordinated universal time – 5 hours)	
<b>Injuries</b>	1 minor	
<b>Property damage</b>	\$750,000 est.	
<b>Environmental damage</b>	120 gallons of diesel fuel released (sheen 3 miles x 67 feet)	
<b>Weather</b>	Visibility 10 miles, cloudy, winds northwest at 6-7 knots, seas northwest 1-2 feet, air temperature 85°F, water temperature 82°F	
<b>Waterway information</b>	The Main Pass lease area of the Gulf of Mexico lies northeast of the Pass A Loutre entrance to the Mississippi River and abuts the Louisiana coastline.

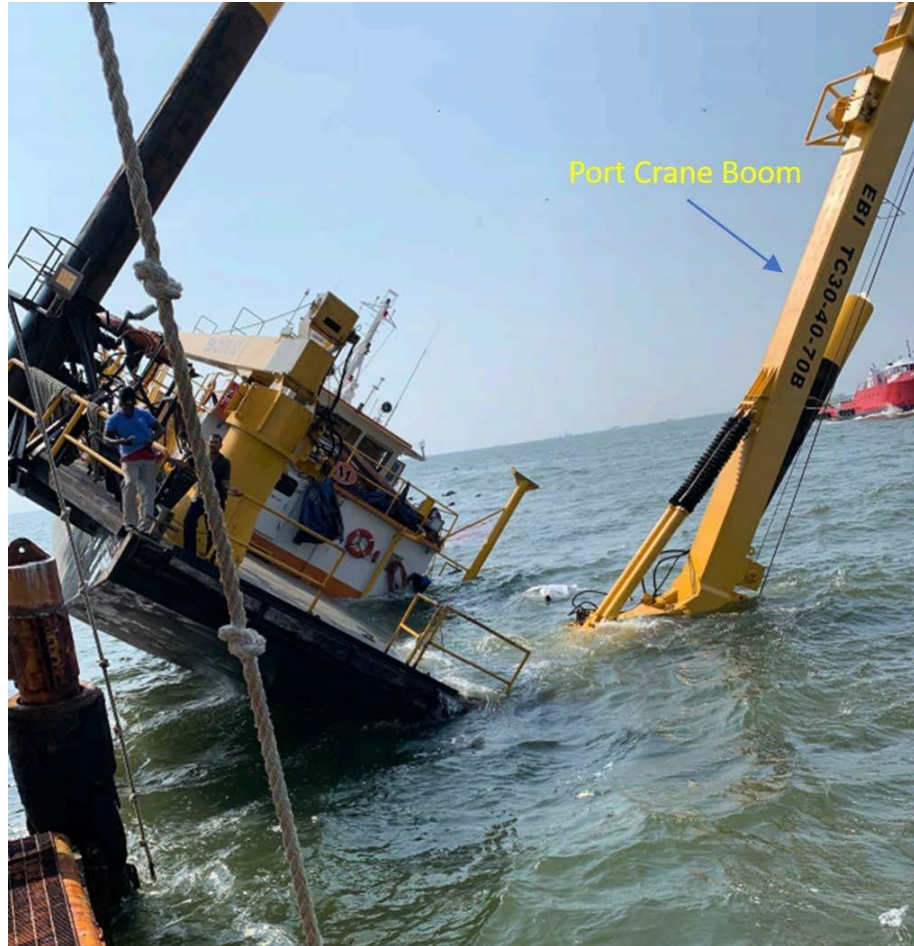
**The *Kristin Faye* tilting over into the water with two crewmembers on the starboard side of the bow. (Source: Sanare Energy Partners, LLC)**

Because the *Kristin Faye* overturned in less than a minute, it is likely that the seabed below the port leg became unstable, causing the leg to settle very quickly in what is known as a “punch through” in the industry. This caused the liftboat to lean over despite the effort of the captain to raise (retract) the other two legs.

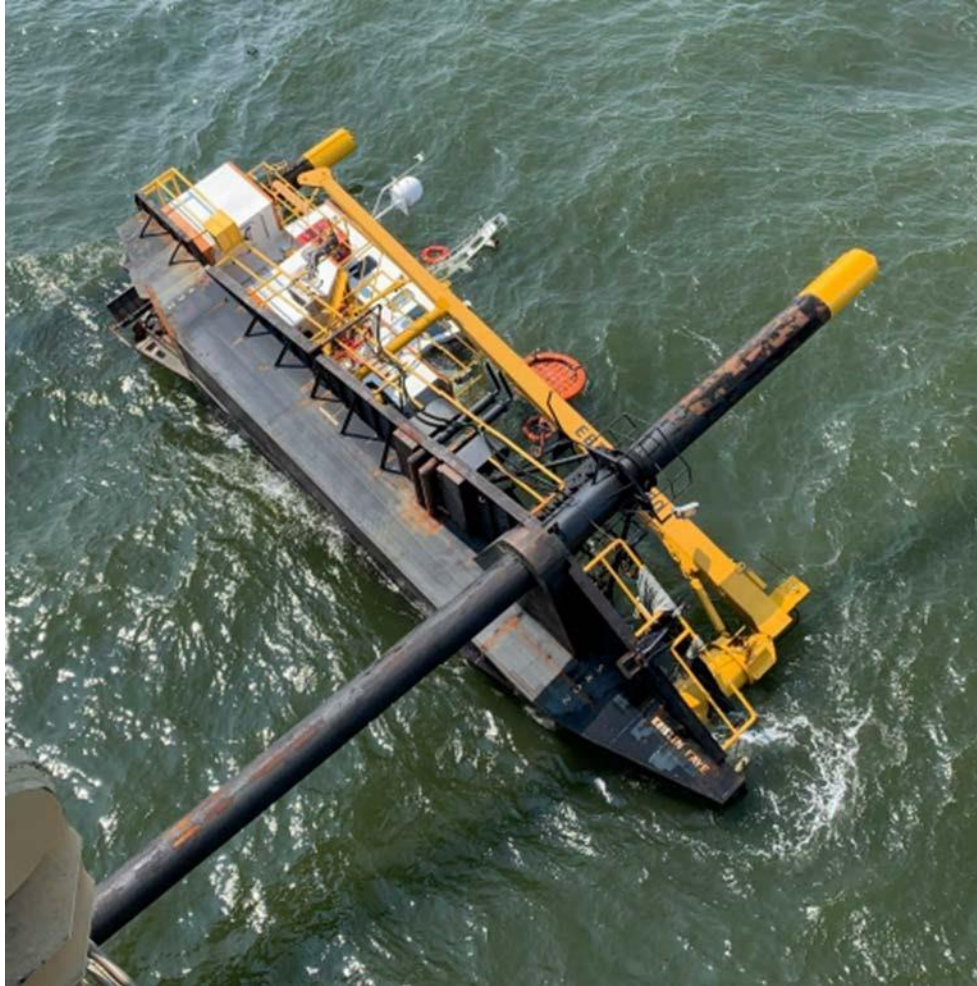
About 5 hours later, the *Kristin Faye* was resting on the seafloor nearly submerged, with just a small part of the starboard bow protruding out of the water. On September 12, a contractor began salvage operations. Salvage divers reported that the port leg had penetrated roughly 40 feet down into the mud, and the port side of the vessel was completely embedded in the mud. Salvage operations continued daily; however, challenging weather conditions impeded a successful salvage. On September 13, the vessel's owner declared the *Kristin Faye* a total constructive loss, with estimated cost of damages at \$750,000. The salvage company was eventually able to right the *Kristin Faye* and transport it to a scrapyards in Belle Chase, Louisiana, where it arrived on October 7.

Starboard side of the toppled *Kristin Faye*, taken from *Platform AQ*. (Source: Sanare Energy Partners, LLC)

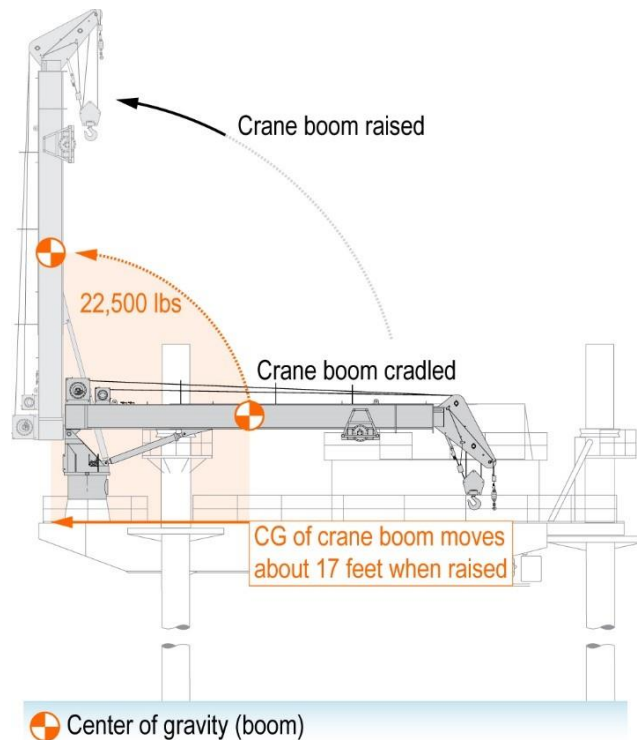
After waiting for an hour at the elevated level, the captain raised the boom. Once the port crane boom was moved from its cradle (horizontal position) to the vertical position, the 22,500-pound boom’s center of gravity shifted about 17 feet toward the port crane pedestal at the forward port corner of the liftboat. With this shift, the weight supported by the port forward leg pad increased due to the boom’s weight shift toward it. The weight supported on the forward port pad increased until the pad suddenly “punched through” the bottom, resulting in the vessel overturning

When the captain raised the *Kristin Faye's* port crane boom, its center of gravity shifted about 17 feet.

The National Transportation Safety Board determines that the probable cause of the overturning of the liftboat *Kristin Faye* was the company's inadequate preload procedure that did not account for crane movements or the planned loads (weights) to be lifted, resulting in a "punch through" of one of the vessel's three legs.

Prior to jacking up to expected operating height and commencing operations, liftboat operators should conduct preload tests, with the hull close to the water, that simulate all planned operational loads.

A preload test should account for the most extreme loading conditions the liftboat will experience at the elevated level. In anticipation of lifting a 17,000-pound pressure vessel onto the platform, the preload test for the *Kristin Faye*, a liftboat without preload tanks, should have included sufficient weights, appropriately placed to replicate the load on each of the pads. For instance, the *Kristin Faye's* preload test could have included locating the boom, with the pressure vessel attached, in the position that would have applied the greatest force on the respective pad.
