Topics in Safety, Risk, Reliability and Quality

Alec Groysman

Corrosion Problems and Solutions in Oil Refining and Petrochemical Industry

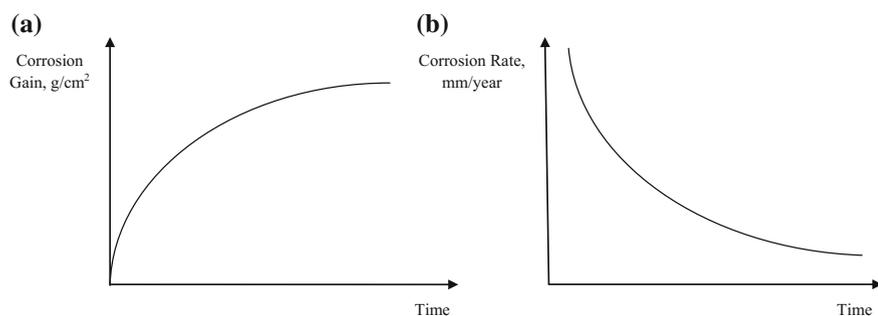
Fig. 4.1 a Kinetic curve for corrosion of iron in contact with H₂S (the mass of metal increases with time—corrosion gain). b Changes of corrosion rate of iron in contact with H₂S with time

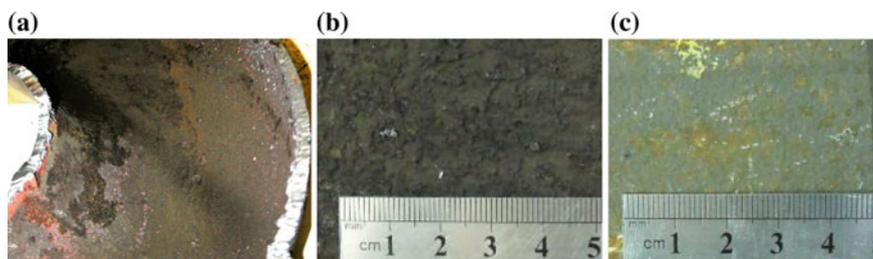
Inner surface. Iron sulfides were formed inside the pipes.

Fig. 4.4 **a** Inner surface of corroded pipe (black deposits—iron sulfides). **b** Magnification of the figure **a**. **c** Outer surface of corroded pipe

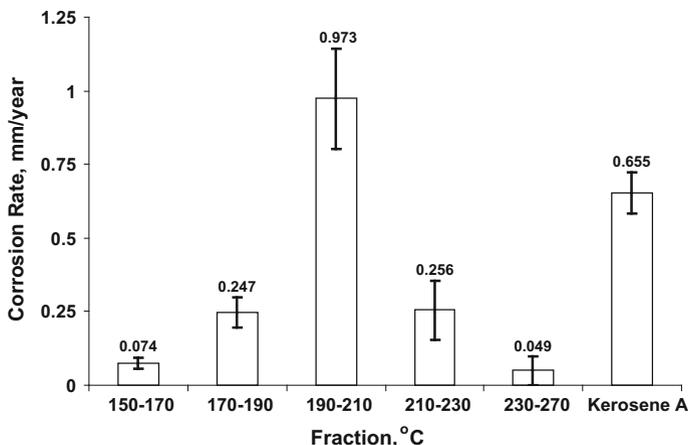
Fig. 4.6 Corrosion rate of carbon steel in various fractions of kerosene “A” (150–270 °C) [46]. Acid kerosene fraction was distilled from acid crude oil ‘Azeri’

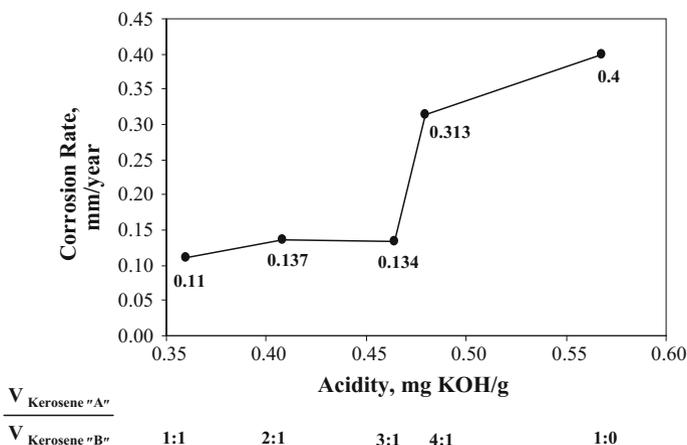
Fig. 4.7 Corrosion rate (mm/year) of carbon steel versus total acidity of kerosene (blended samples). Kerosene “A” is acidic (TAN = 0.57 mg KOH/g) and kerosene “B” is non-acidic (TAN < 0.01 mg KOH/g). T = 185–200 °C; P = 1 bar; Duration—3 days [46]

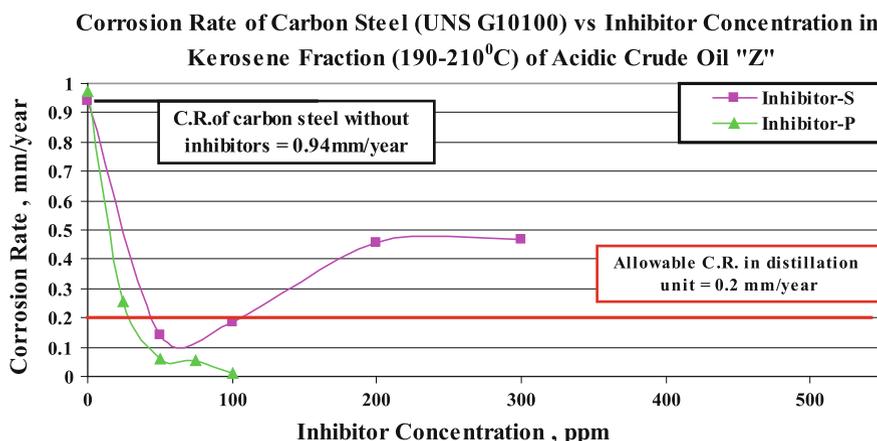
Fig. 4.8 Corrosion rate of carbon steel versus phosphorus (P)- and sulfur (S)-based inhibitor concentration in acidic kerosene at 195 °C [91]

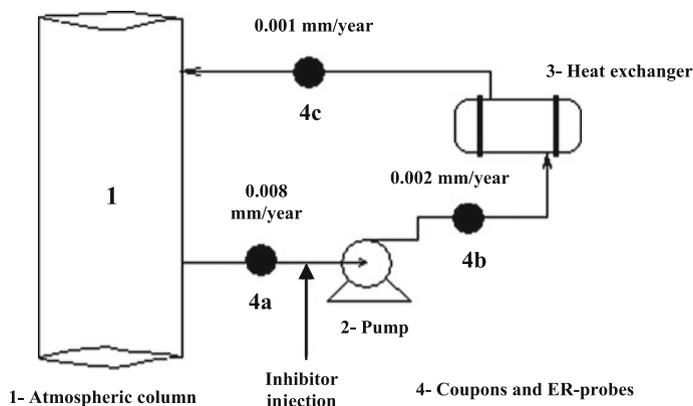
Fig. 4.9 Naphthenic acid control by injection of phosphate ester inhibitor in acid kerosene ‘Azeri’ at the distillation unit. Corrosion rates of carbon steel coupons are average during 3 months run

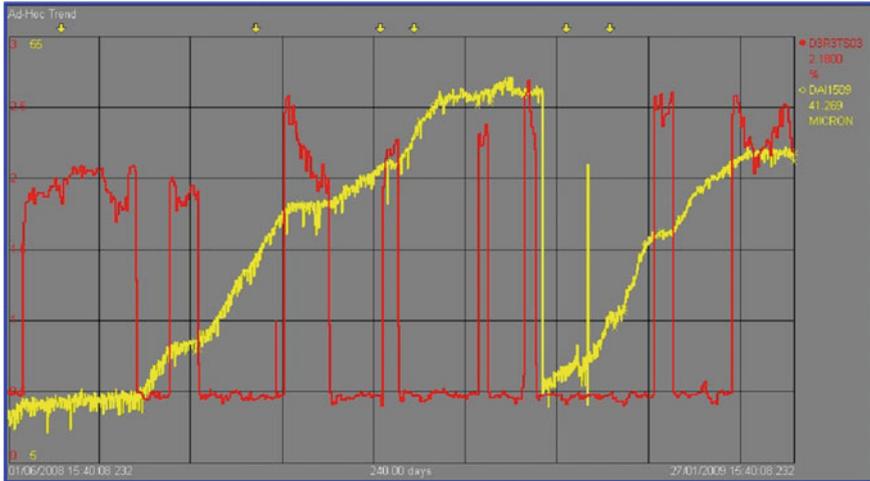
Fig. 4.11 Trend in atmospheric distillation column (PI data, 240 days): ER-probe readings (yellow) and sulfur content (red) in crudes. When corrosion rate (calculated as the differential of yellow line) is low there is no increase of yellow line with time (the corroded thickness of ER-sensor in microns is constant—no corrosion). When corrosion rate is high, the corroded thickness of ER-sensor increases with time and yellow line also increases (there is a constant slope of yellow line—corrosion rate is high)

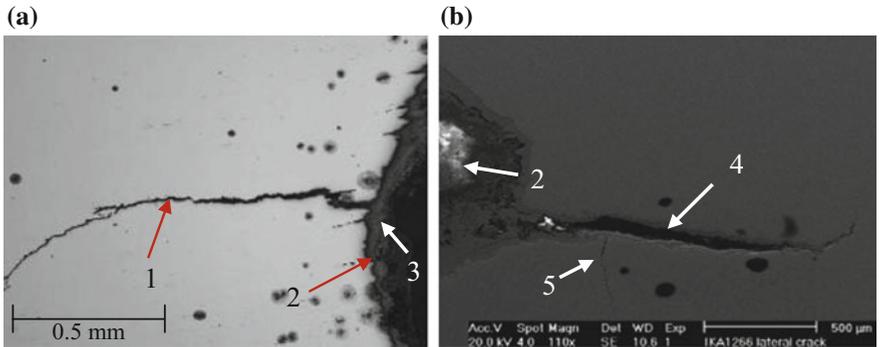
Fig. 4.15 **a** Longitudinal metallographic cross-section through the failed stud bolt: 1 Crack; 2 Corrosion products; 3 Fracture surface. **b** SEM image of the longitudinal metallographic cross-section through the failed stud bolt: 4 A crack parallel to the fracture surface; 5 A secondary crack

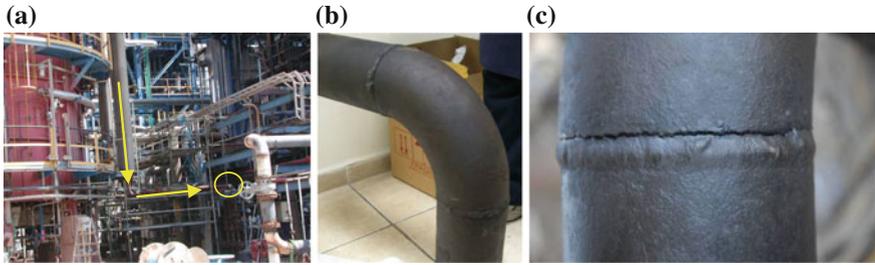
Fig. 4.16 a General view of the failed pipe with the elbow (yellow circle) to the furnace at the HDS unit. b, c Crack in the heat affected zone (HAZ). Seamless carbon steel pipe (diameter 100 mm) after 16 years of the hydrogen service. T = 280 °C (with peaks to 320–380 °C), P_{H₂} = 46 Bar

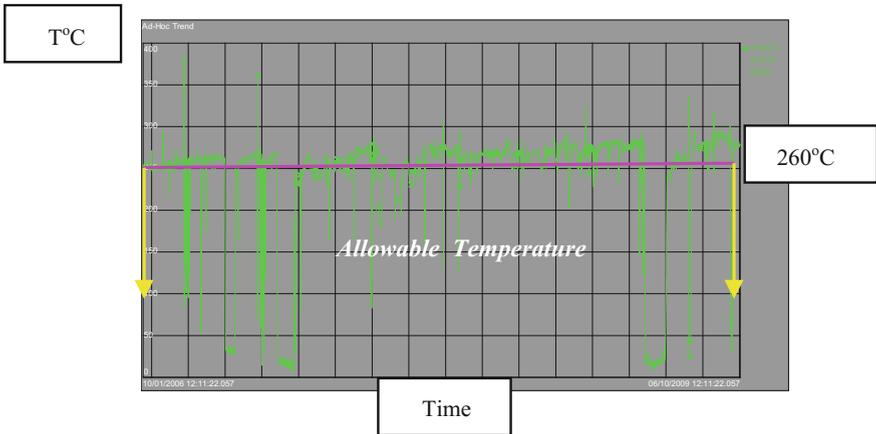
Fig. 4.17 Change of temperature of hydrogen gas in the pipeline. PI data (Plant Information System). Period—last 4 years before the failure (P_{H₂} = 46 Bar)

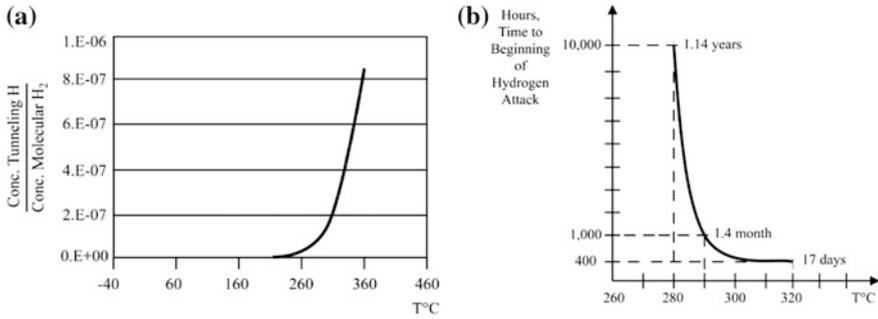
Fig. 4.19 **a** Available tunneling hydrogen to molecular hydrogen ratio versus temperature [104]. **b** Time for incipient attack of carbon steel versus Temperature ($P_{H_2} = 46$ bar). Calculated on the basis of API 941 data [121]

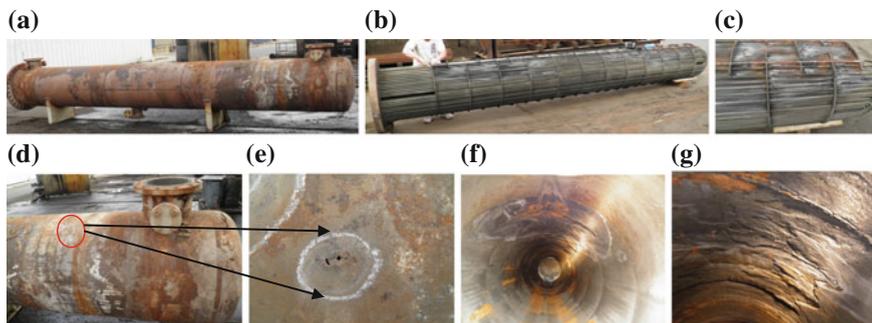
Fig. 4.20 a Failed shell of the reboiler. b U-tube bundle of the reboiler. c White-grey-black deposits on the tube bundle. d, e Holes in the shell. f, g Corroded inner surface of the shell

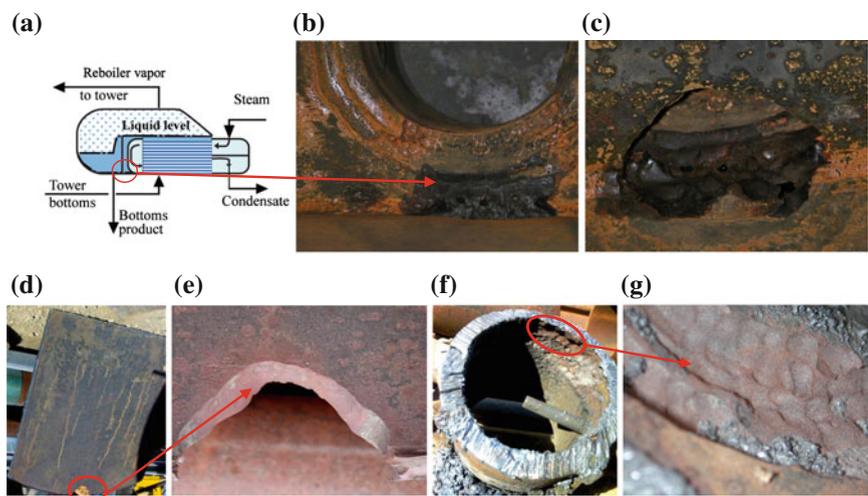
Fig. 4.21 a Reboiler (a scheme). b Corroded failed area (lean amine exit). c Corrosion hole in the separation plate (tube bundle side). d Corrosion hole at the bottom of the separation plate of the reboiler (near the lean amine exit, shell side). e Magnification of the picture d (the view from the lean amine exit, shell side). f The flange (lean amine exit). g Magnification of the picture f (the surface morphology is typical to erosion)

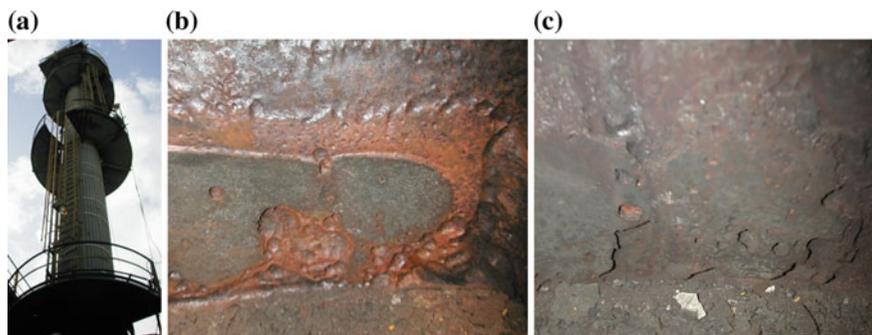
Fig. 4.22 a General view of the stripping tower. b, c Corroded inner surface of wall in the stripper tower

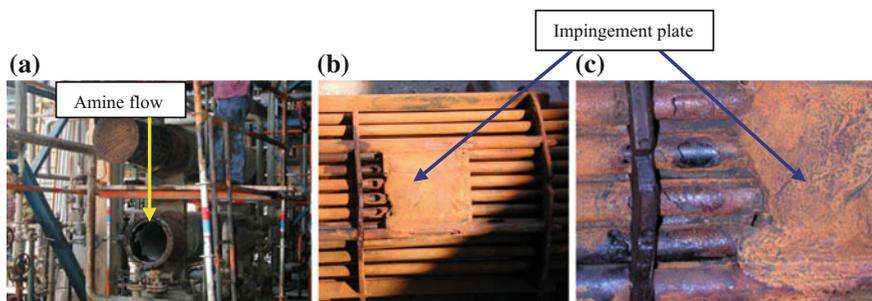
Fig. 4.23 a General view of the heat exchanger with failed tubes. b, c The impingement plate and holes formed as a result of impingement attack

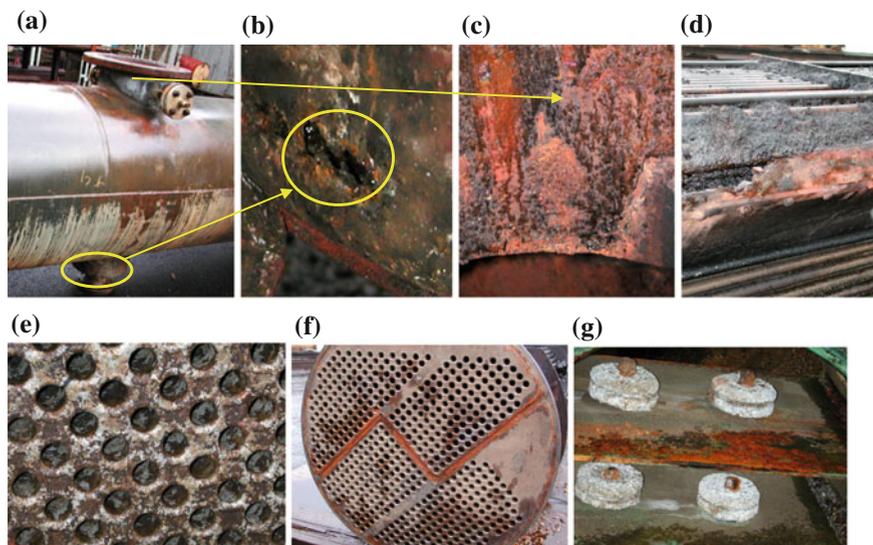
Fig. 5.2 **a** General view of the 1st step vacuum condenser. **b** The hole (10 cm) in the bottom (boot). **c** Rusted *upper part* of the condenser. **d** Deposits on outer surface of titanium tubes in the condenser. **e** Scale inside the titanium tubes and on the tube-sheet (cooling water side). **f** Opposite side (exit of cooling water). **g** Aluminum sacrificial anodes in cooling water (inlet channel)

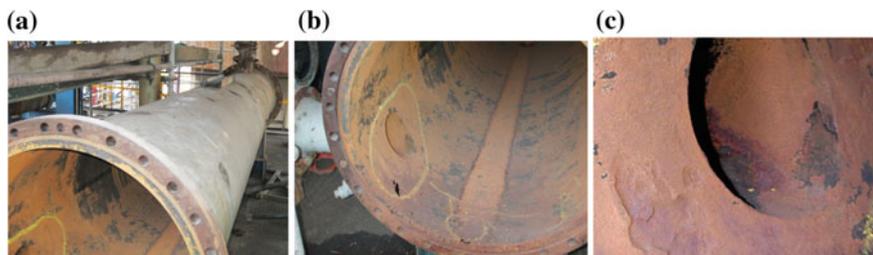
Fig. 5.3 a Corroded inner surface of the shell of the 2nd step vacuum condenser. b, c Localized corrosion near the exit of water condensate from the 2nd step vacuum condenser

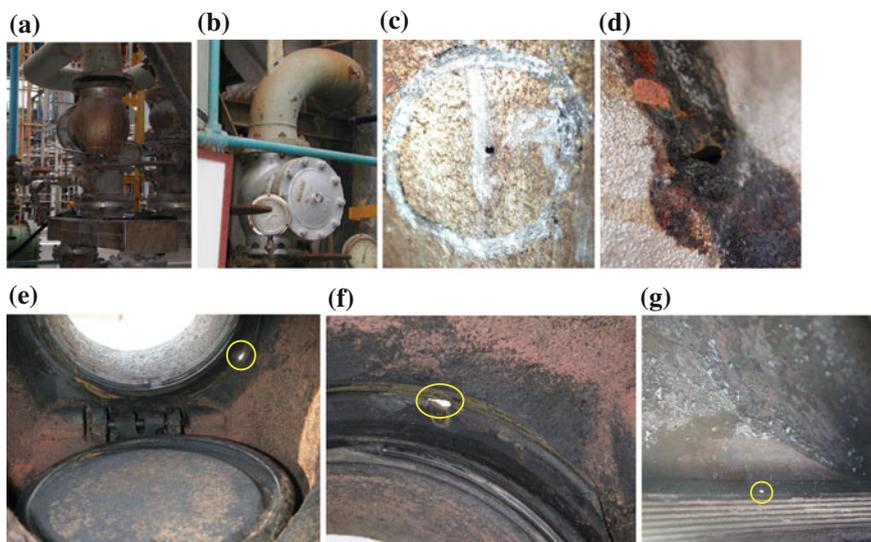
Fig. 5.5 a, b Locations of two failed valves at the vacuum unit. c, d Corrosion holes on the valve body (outside view). e–g Inside view of corroded internals with corrosion holes

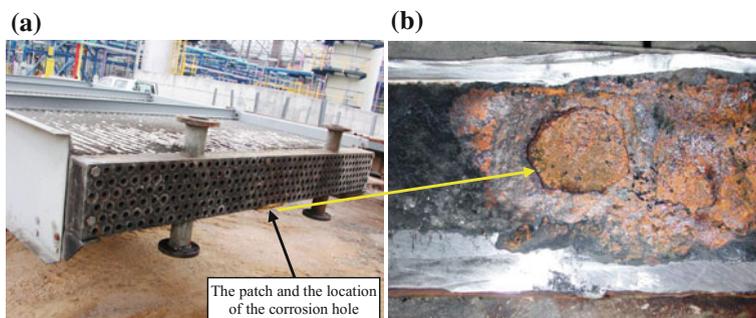
Fig. 5.7 a General view of the air cooler. b The hole and the patch

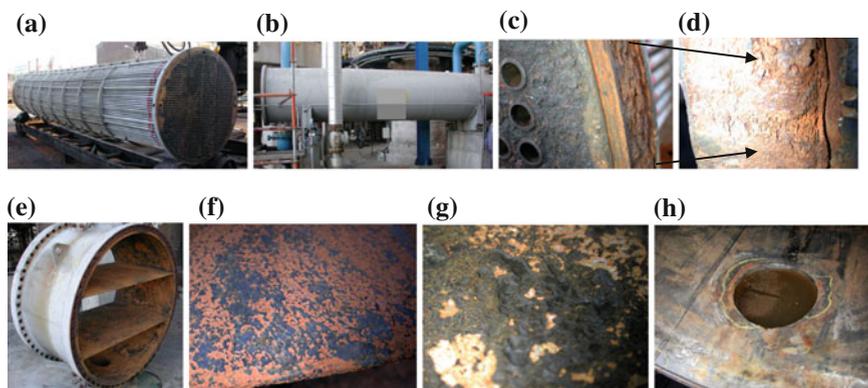
Fig. 5.8 **a** General view of heat exchanger bundle (HDS unit). **b** The shell. **c** Corroded tube-sheet contacted clad SS 316L. **d** Magnification of **c** picture. **e–g** Corroded inner surface of the channel (sour water). **h** Corroded inner surface of the shell inlet (cooling water)

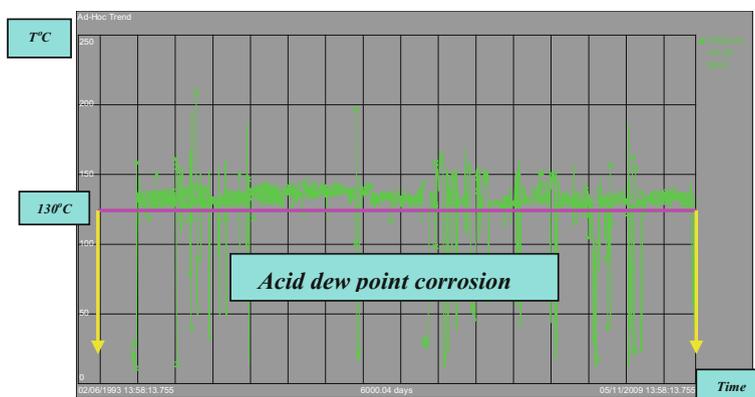
Fig. 5.11 Temperature fluctuations (*green*) of incoming gases to the heat exchanger versus time (PI data)

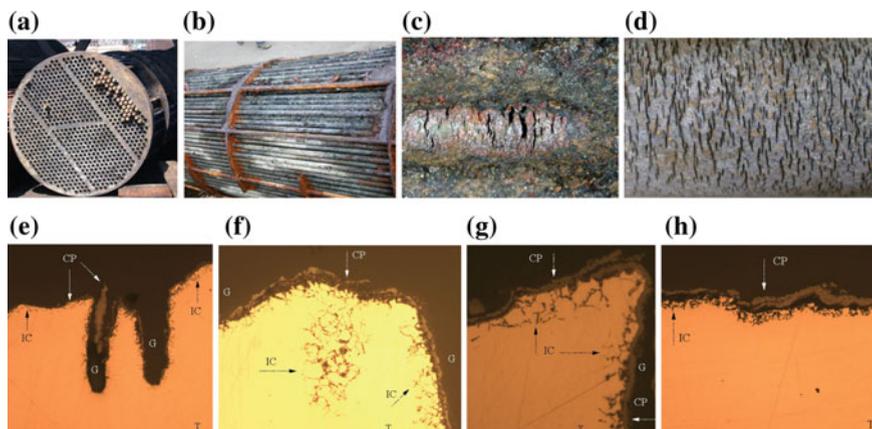
Fig. 5.13 **a** The tube bundle with 60 clogged tubes. **b** Corroded Admiralty brass tubes (with deposits) and corroded carbon steel baffles. **c, d** Cracks, holes and grooves on tube surface. **e–g** Metallographic cross-section of grooves with different magnification (**e**: $\times 100$, **f**: $\times 200$, **g**: $\times 500$): IC—Intergranular corrosion (corrosive attack on grain boundaries), CP—corrosion products, G—grooves, T—tube. **h** Metallographic cross-section near the grooves ($\times 100$)

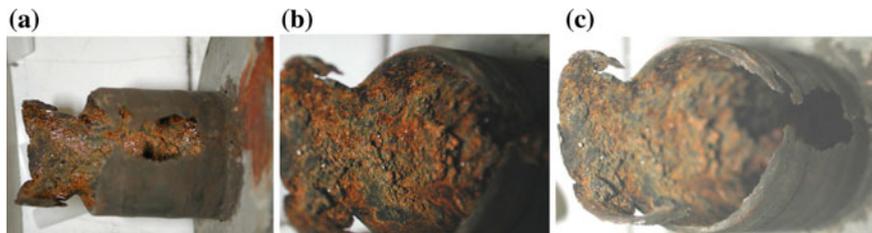
Visual examination and findings. Severe corrosion with black-red-brown corrosion products was found inside the air cooler tubes (Fig. 5.15). The wall thickness of tubes decreased from original 2.336 mm to nil. Corrosion rate was 0.58 mm/year, that is ~6 times greater than allowable value 0.11 mm/year.

Fig. 5.15 a–c Failed corroded tube in the air cooler at the overhead of benzene tower, 4 years of service (BTX unit, petrochemical plant)

Chemical analytical examination showed that corrosion products consist of iron sulfides, iron hydroxides and iron oxides. Sulfates were detected in corrosion products. Chlorides were absent. Two samples of benzene feed to the tower showed

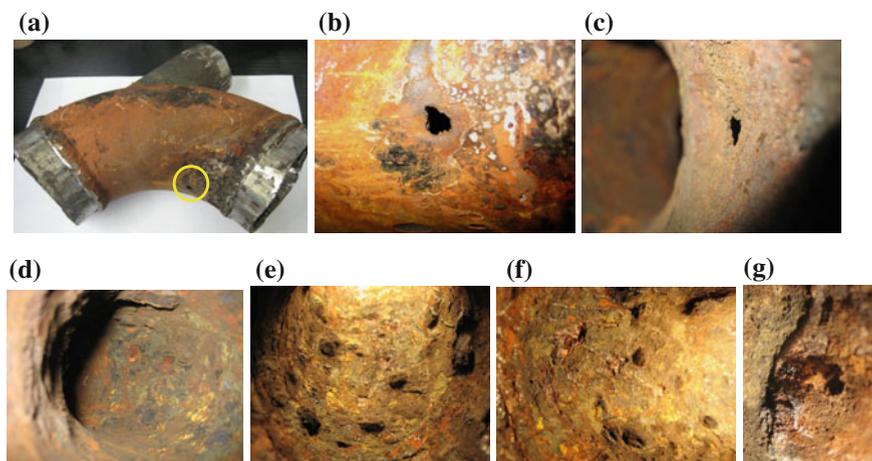
Fig. 5.17 a General view of the pipe section with the hole. b A view of the hole from outside. c A view of the hole from inside. d–f Inside corroded surface with rust tubercles, g a pit under the tubercle

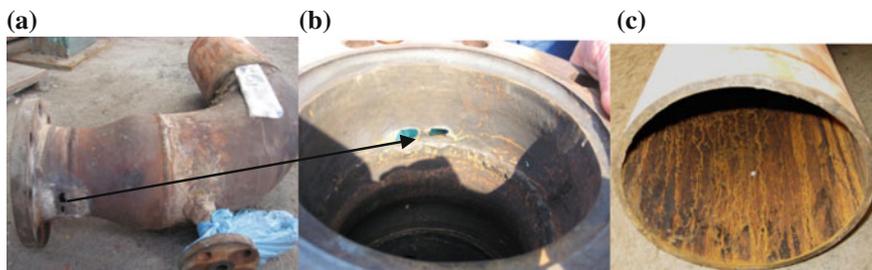
Fig. 5.18 a Failed elbow with corrosion holes. b The holes at the cone end before the flange. c Inlet of liquid mixture of sulfolane and BTX into the elbow

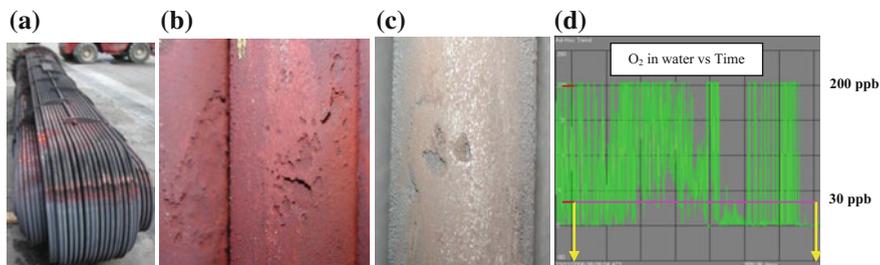
Fig. 5.20 a Failed U-tube bundle of the steam generator. b, c Pits (1 mm deepness) on outer surface of U-tubes. b Rust before cleaning. c Outer surface after cleaning. d Changes of concentration of dissolved oxygen in water with time (PI data). Allowable maximum concentration is 30 ppb

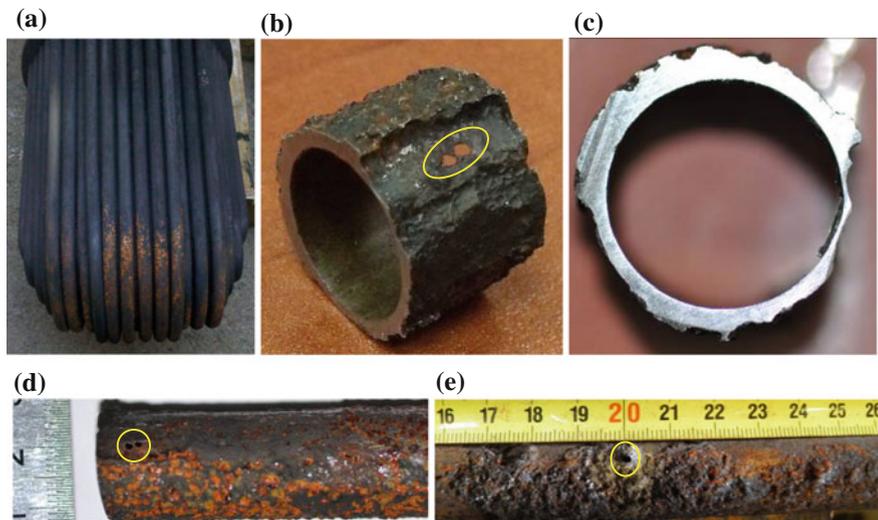
Fig. 5.22 **a** General view of failed tube bundle. **b** Failed tube with two holes under the “step” (stair). **c** Macroscopic cross-section perpendicular through the tube near the holes. **d** Failed tube with two holes (~ 2 mm). **e** Failed tube with a hole (~ 2 mm)

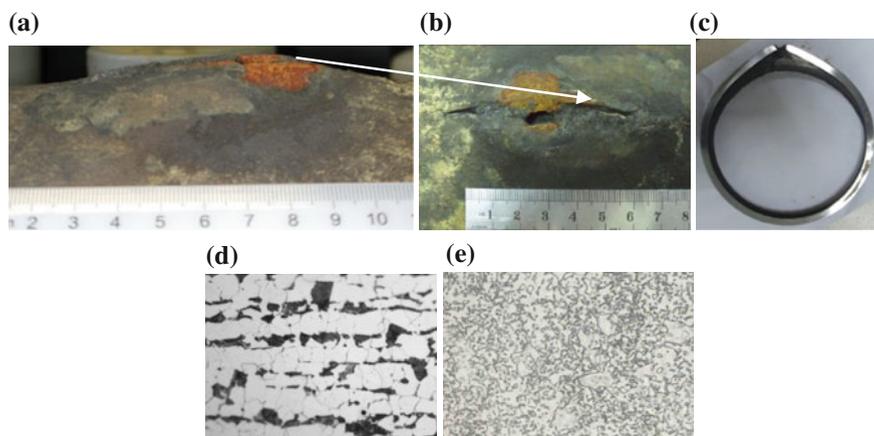
Fig. 5.23 **a** The pipe with the bulging. **b** The bulging, fissures and splitting (crack) on the external surface. **c** Macroscopic cross-section through the failure zone of the pipe. **d** Micro-structure of the pipe, 'cold' side ($\times 600$). **e** Micro-structure of the pipe failure area, 'hot' side—spheroidal cementite particles in a matrix of ferrite ($\times 1000$)

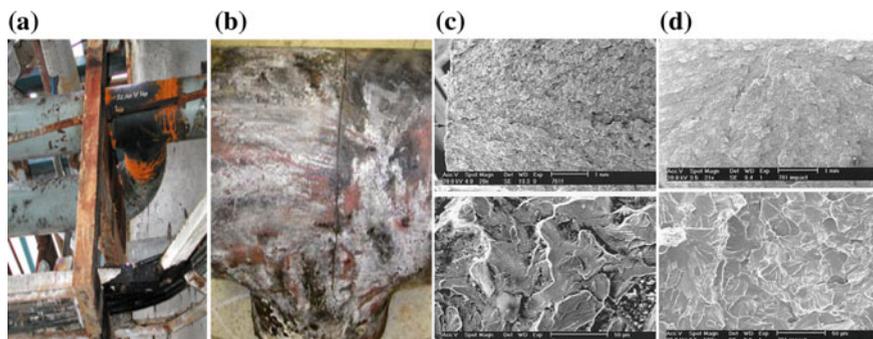
Fig. 5.25 a The T-shaped pipe fitting on the support (location of failure in torch piping). b The cracked T-shaped pipe fitting. c The fracture surface after the opening of the crack (inner surface of the fitting). d The fracture surface of the impact specimen (taken from the same pipe) after the Charpy test

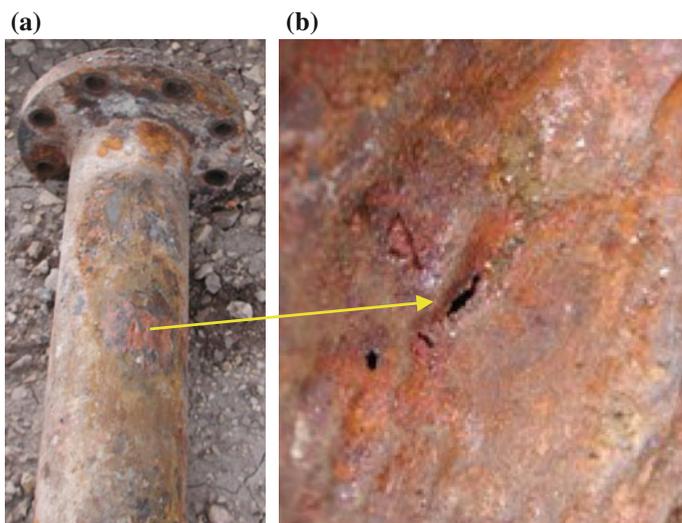
Fig. 5.28 **a** Corroded pipe for BTX transportation. **b** The hole in corroded pipe

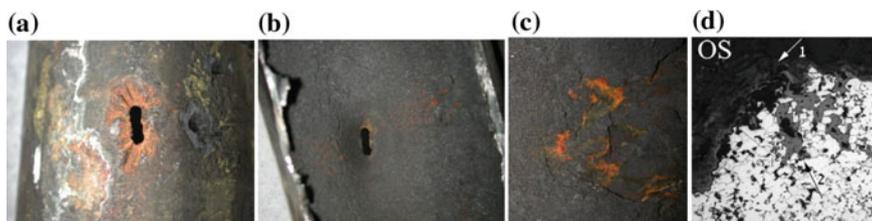
Visual examination and findings. The failed pipe segment was welded on both ends to segments from the original piping system. Wide hole surrounded by deformed tube wall due to bulging was found in the pipe closest to the fire (Fig. 5.32).

Corrosion around the hole and irregular deposits of grey, white and yellow color were detected outside. Uneven thick black scale was found inside the pipe in the area around the hole. Even (smooth) dense black-grey scale was found inside the pipe in the area opposite to fire. The defect leading to the hole originated on the outer tube surface. A significant decrease on the wall thickness of hot area of the tube occurred in relation to the cold side. The hot side-inner surface close to the hole had oxide layer $300\text{--}400 \text{ }\mu\text{m}$ in thickness. The cold side-outer surface had dense layer of corrosion products. The inner surface showed slight non-uniform oxide layer.

Fig. 5.32 a, b The view of the hole in the pipe from: a outer side; b inner side. c The inner surface of the tube near the hole close to the fire: one can see uneven thick scale of corrosion products. d Metallographic cross-section ($\times 240$) close to the hole in failed tube (hot side): OS—outer surface, 1—corrosion products, 2—intergranular corrosion

Metallographic examination. Loose layer of corrosion products cover the outer surface and significant intergranular corrosion attack was progressing over 0.15 mm beneath the surface.

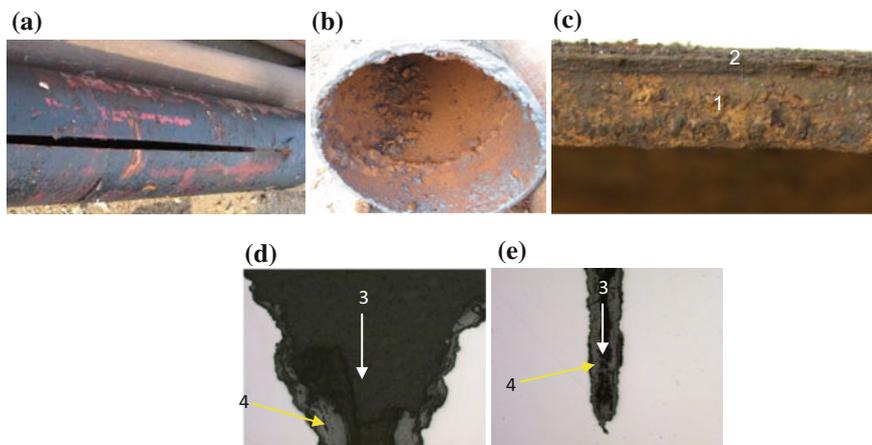
Fig. 5.33 **a** General view of failed fire-fighting pipe with longitudinal crack. **b** Inner rusted surface of the pipe. **c** Different regions of the fracture: 1—there was no weld ($\sim 80\%$ of the wall thickness), 2—weld after crack. **d, e** Metallographic cross-section through the pipe relatively far from the failure: **d** the crack beginning from the inner surface of the pipe. **e** The crack edge: 3—crack, 4—corrosion products

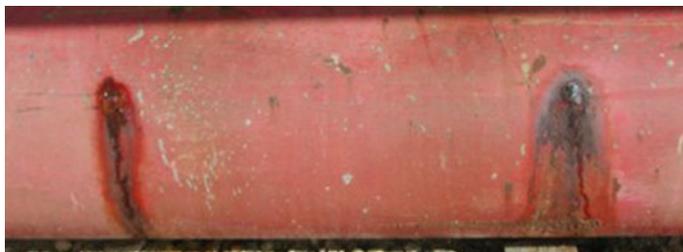
Fig. 5.34 Fire-fighting pipe with rust and leaks. Pits were formed in the welds inside the pipe and penetrated through the pipe wall

Cause of failure and its explanation. The lack of welding inside the pipe wall served as a crevice (crack) which progressed with time through the wall as a result of corrosive attack by stagnant extinguishing water inside the pipe. When the crack progressed to a depth of $\sim 90\%$ of the wall thickness, the pipe lost mechanical properties and the final fracture occurred. Pit were formed in the welds inside the pipe. Some pits penetrated through the pipe wall and caused leaks with formation of rust on outer surface of the pipe (see Fig. 5.34).

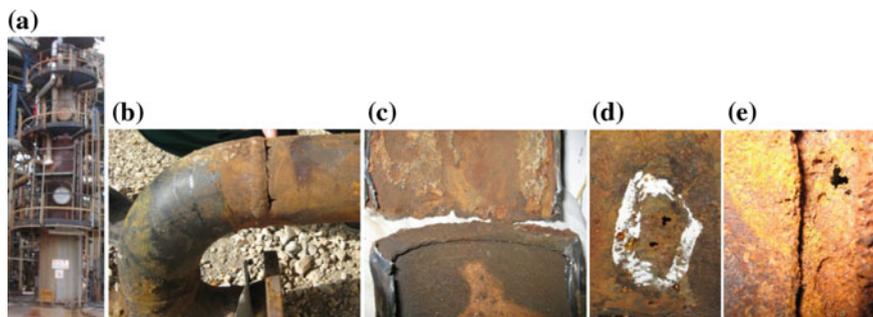
Fig. 5.35 **a** The tower for absorption HCl by aqueous caustic soda solution (CCR unit) (the failed pipe is white luminous covered with aluminum jacket). **b–d** The pipe with circumferential hole in the weld (HAZ): **b** outside view. **c** Inside view. **d** The bend with two holes in the weld. **e** Corroded inner surface of the weld (HAZ) in the bend (with holes)

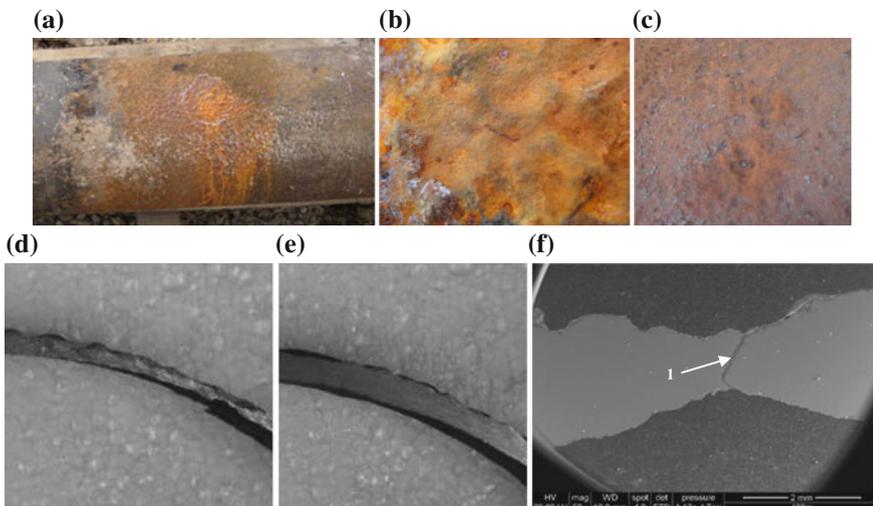
Fig. 5.37 **a** General view of the failure on the kerosene pipe. **b** External corroded surface with the crack. **c** Inner corroded surface (kerosene side). **d, e** Macroscopic cross-sections of the pipe: **d** Close to the crack. **e** Far from the crack. **f** Metallographic cross-section through the pipe, crack area (SEM photo): *l*—crack

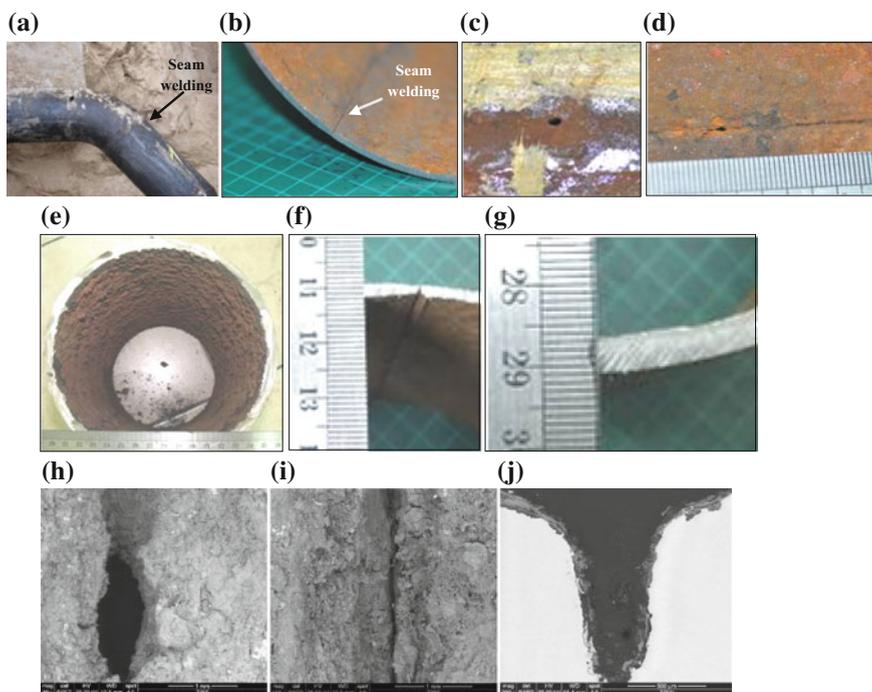
Fig. 5.39 **a** The pipe bend with the hole at the 'hour 6' in the ditch. **b** The seam welding along the pipe. **c** The leak area (outer surface). **d** The leak area (inner surface). **e** The view on the pipe wall thickness (rust inside). **f** Top-pipe segment with the seam weld. **g** Lower pipe section. **h** SEM image of the inner surface of the pipe section (the failure area). **i** SEM image of the inner surface of the pipe section (near the failure zone). **j** SEM photo of metallographic cross-section through the pipe section (the weld zone)

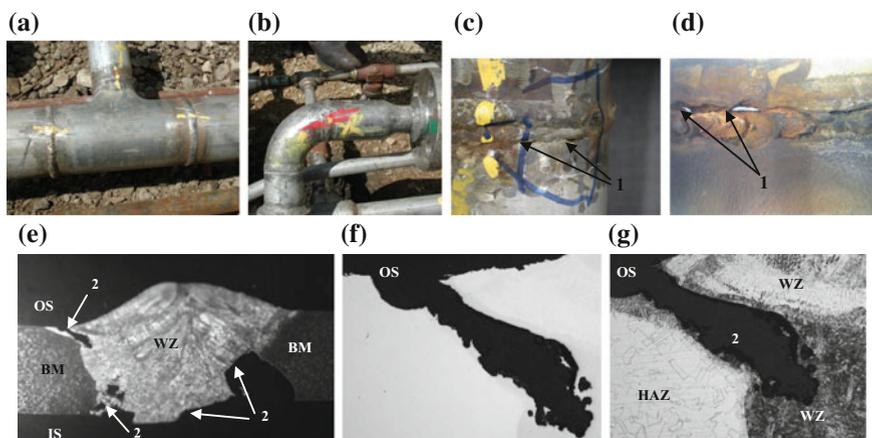
Fig. 5.40 a, b General view of welded pipes. c, d Failed welds (with holes 1): c outer surface; d inner surface. e Macroscopic cross section of the weld: 2—location of corrosion; WZ—weld zone, BM—base metal, OS—external surface, IS—inner surface. f, g Metallography of weld in the location of failure ($\times 60$): f before etching. g after etching: HAZ—heat-affected zone

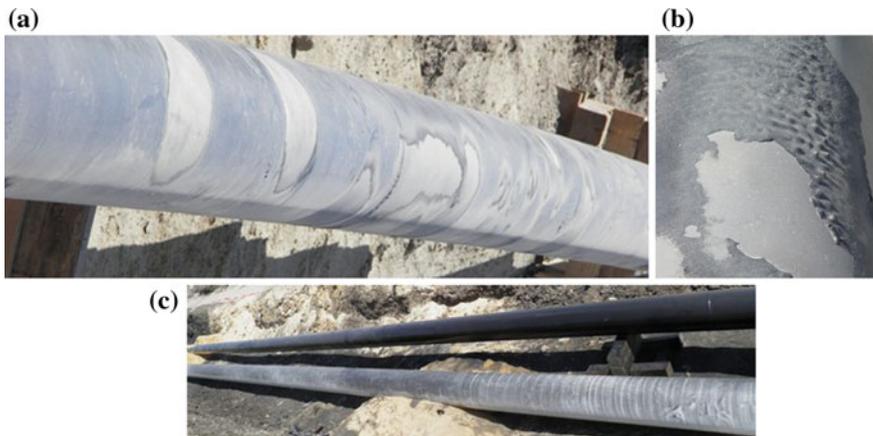
Fig. 5.41 a Repair of the pipeline. b Destroyed polyurethane coating before its removing and repair. c The pipeline (up) repaired with polyurethane coating (500–600 μm in thickness)

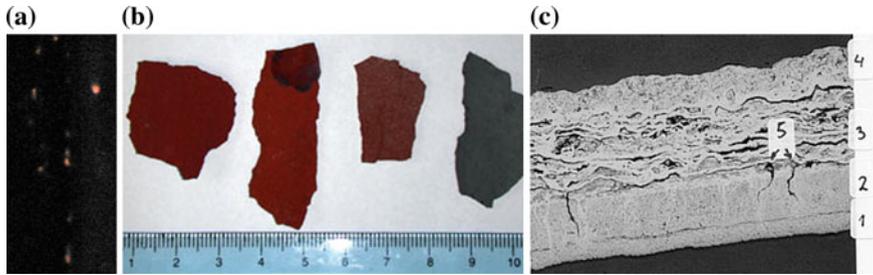
Fig. 5.42 **a** ‘Glowing’/‘hot luminous spots’ on the outer surface of the tubes in the furnace (during service). **b** Scale formed on the surface of the 9Cr-1Mo pipes in the furnace: *red*—contact with combustion gases, *grey*—contact with the pipe surface. **c** SEM photo (magnification $\times 100$) of metallographic cross-section of oxides: *1-4*—four oxide layers (0.4–0.5 mm in thickness), *1*—contact with the pipe surface, *5*—cracks in the oxide layer no. 2

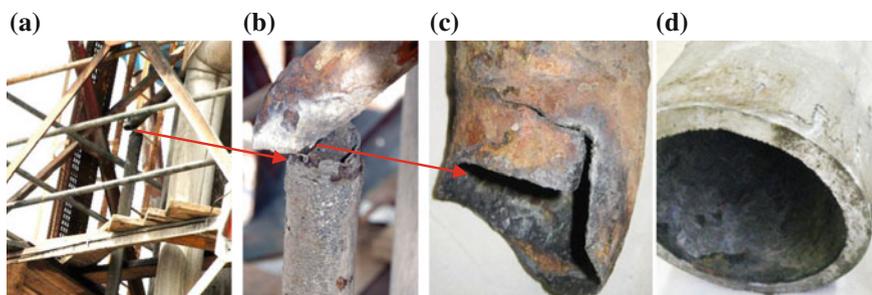
Fig. 5.44 **a** Corroded cracked drain pipe in the ‘molecular seal’. **b** Corroded cracked pipe (magnification of the picture **a**). **c** Corroded cracked pipe after the failure. **d** Drain pipe far from the failure

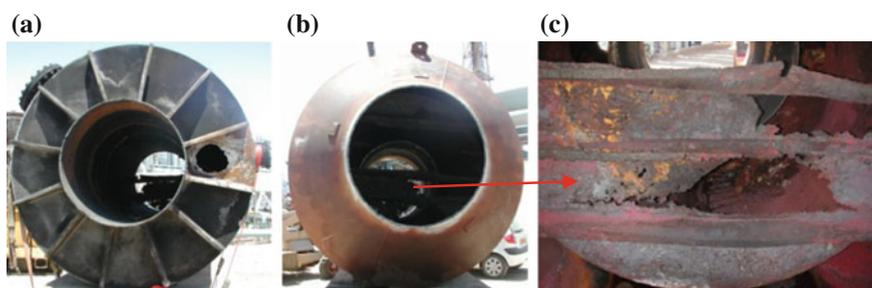
Fig. 5.45 **a** Corroded lower part of the ‘molecular seal’ (the location of corroded cracked drain pipe). **b** Upper part of the ‘molecular seal’ (corroded parts inside). **c** Corroded parts inside the ‘molecular seal’

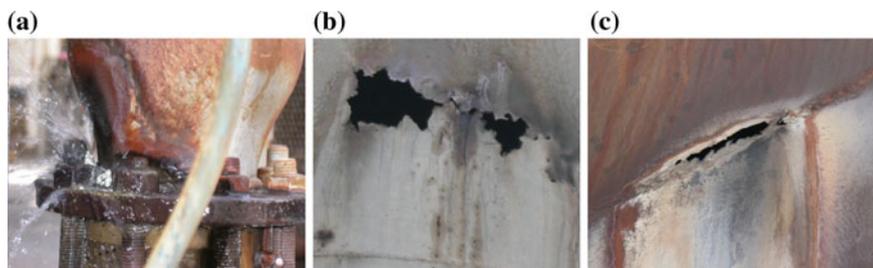
Fig. 5.48 **a** The leak in the pipe connection from the scrubber to the pump. **b** The hole in the wall (the location of acid gases escape). **c** The collapse of the tank shell in corroded area due to extremely low wall thickness

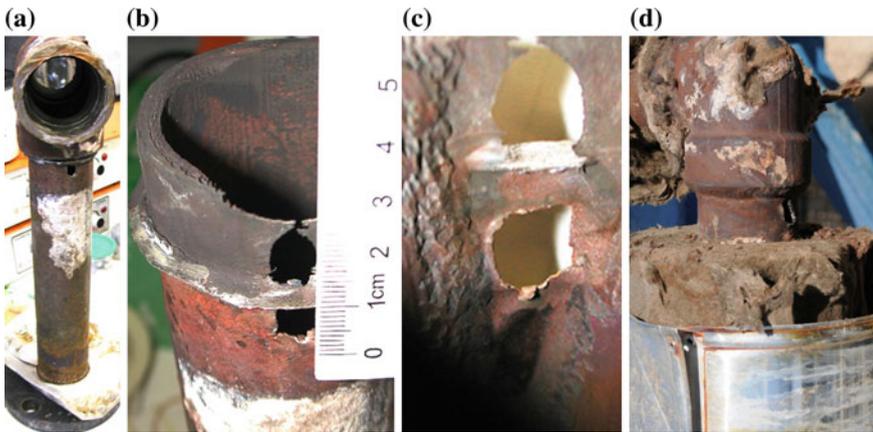
Fig. 5.49 **a** The tube connection (T) with the hole. **b** Holes (outside view). **c** Holes view from the inside (signs of erosion around holes). **d** The hole in the tube bend with lack of thermal insulation

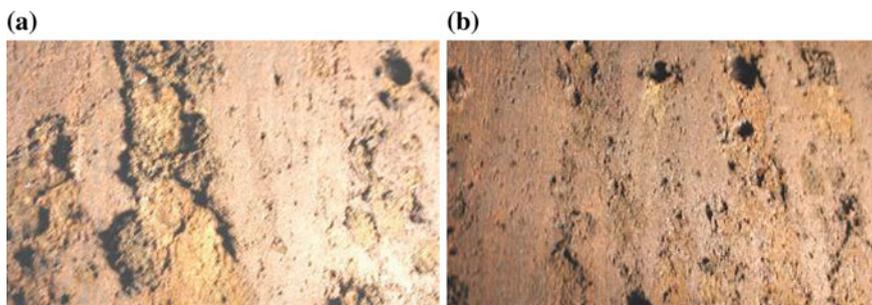
Fig. 5.53 a, b Corroded and pitted inner surface of the tank (50 m^3) containing solid sodium chloride (NaCl) for absorption residual water from kerosene or naphtha

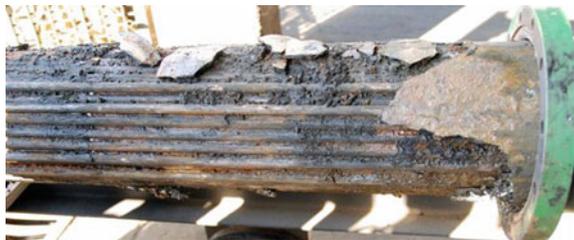
Visual examination and findings. The heat exchanger was shutdown and open. Clogging by deposits was found outside tubes (Fig. 5.56).

Fig. 5.56 Failed heat exchanger with deposits

Heat exchanger has been clogged long ago by corrosion products formed in the pipeline with untreated cooling water.

Cause of failure and its explanation. The water flow velocity was very slow outside the tubes, heat exchange was poor, and that gave rise to heating which in its turn resulted in deposit formation outside the tubes. Corrosion products consisted of rust.

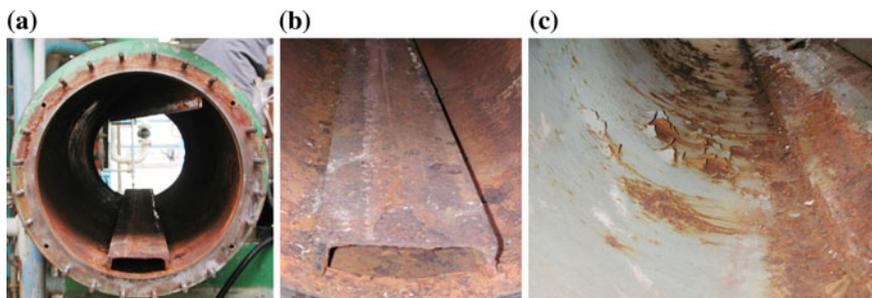
Fig. 5.57 **a** The cooler (the 3rd stage of the compressor). **b** Inner rusted surface (magnification of the picture **a**). **c** Failed epoxy coating (the 2nd stage of the compressor)

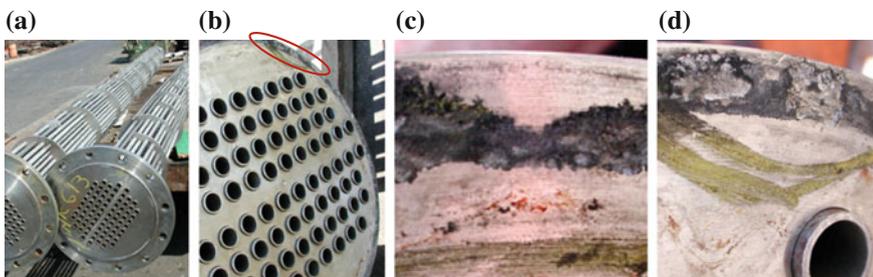
Fig. 5.60 **a** General view on stainless steel bundles of heat exchangers. **b** Tube-sheet with failed area as a result of crevice corrosion (*red*). **c**, **d** shallow pits (crevice corrosion)

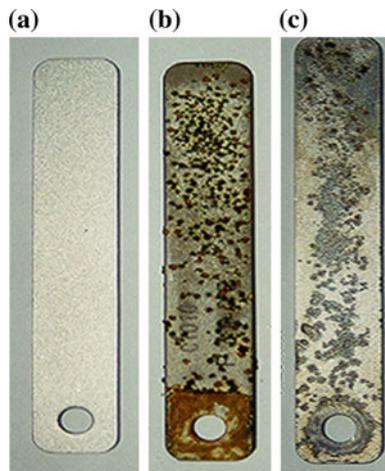
Fig. 5.64 **a** Original carbon steel coupon. **b** Coupon with adsorbed copper particles (after 30 days in cooling water). **c** The same coupon after removing copper particles. Average corrosion rate of carbon steel coupon—0.06 mm/year. Pitting corrosion rate—1.8 mm/year

Heat exchangers can be made from different alloys, for instance, carbon steel and Admiralty brass. In order to have the galvanic corrosion occurred, it is not always necessary two different alloys to be in physical contact. Galvanic corrosion can be caused by the presence of metal cations in water. If copper corrosion inhibitors are not injected in cooling water, copper may corrode in water in the presence of dissolved oxygen, and then deposit on carbon steel surface. As a result, severe pitting corrosion takes place under copper deposits (Fig. 5.64).

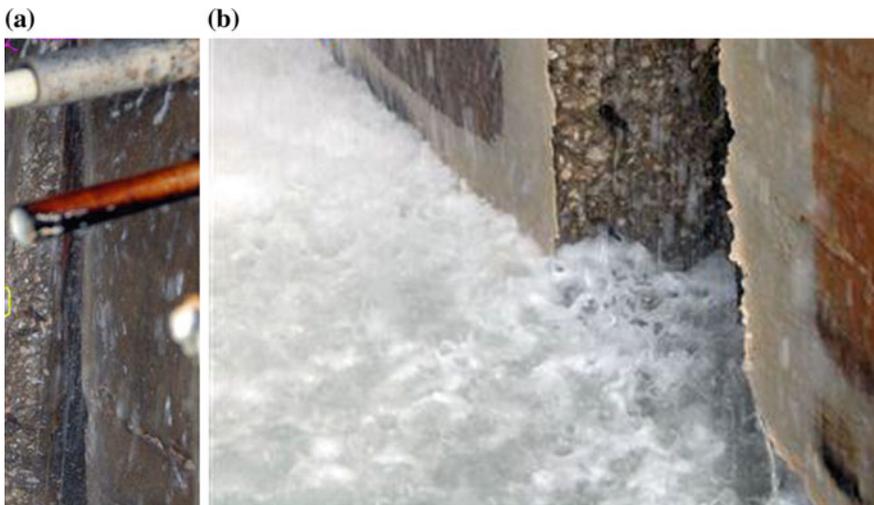
Fig. 5.66 **a** Polyethylene pipe for injection of concentrated sulfuric acid. **b** Corroded concrete in the vicinity of sulfuric acid injection point

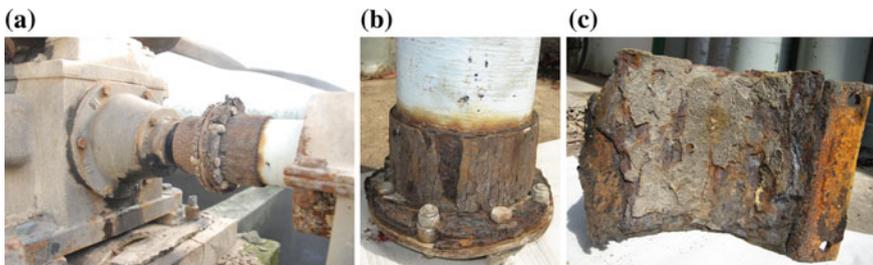
Fig. 5.67 a, b Corroded axis of the fan (cooling tower). c Corroded base of the fan

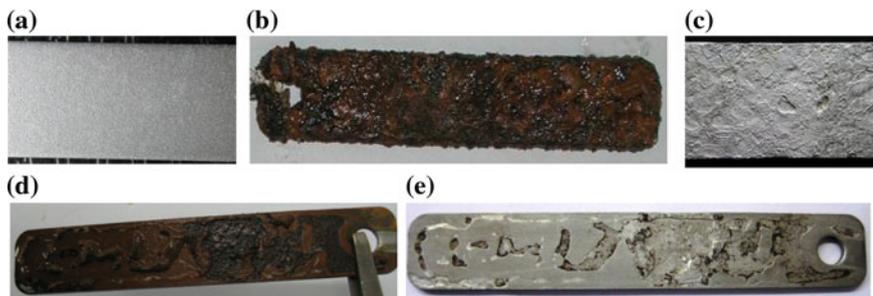
Fig. 6.5 **a** Original carbon steel (C1010) coupon. **b–e** Coupons after examination in cooling water condensate containing inhibitor Na_2SiO_3 . **b** Coupon in cooling water in the box (stagnation, 628 days). Corrosion rate is 0.058 mm/year. Concentration of inhibitor varied from 0 to 470 ppm SiO_2 . **c** Coupon's surface after chemical cleaning from corrosion products. **d** Coupon in cooling water in the box (stagnation, 123 days). Corrosion rate is 0.065 mm/year. Concentration of inhibitor varied from 13 to 190 ppm SiO_2 . **e** Coupon's surface after chemical cleaning from corrosion products

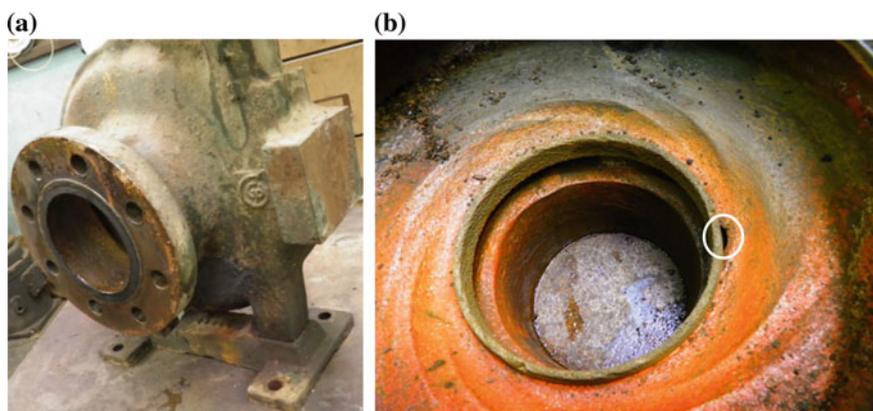
Fig. 6.7 a General view of failed pump. b Corroded inner surface of centrifugal pump with large corrosion hole (marked with white circle)

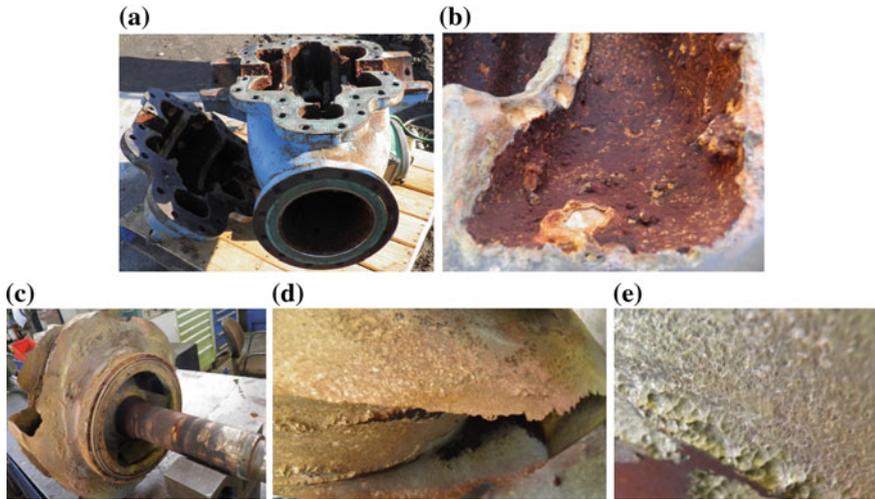
Fig. 6.8 Failed centrifugal pump for water service. **a** General view. **b** Rust with tubercles inside the pump. **c–e** Eroded impeller

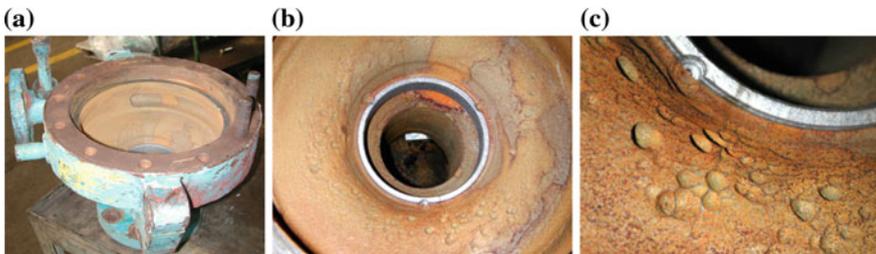
Visual examination and findings. Shallow pits were detected on the inner surface of the pump (cast iron) (Fig. 6.11). Bushing (SS 316) was not damaged.

Fig. 6.11 a General view of corroded diffuser made from cast iron of amine pump. b, c Pitted inner surface (inner bushing made from SS316 is not damaged)

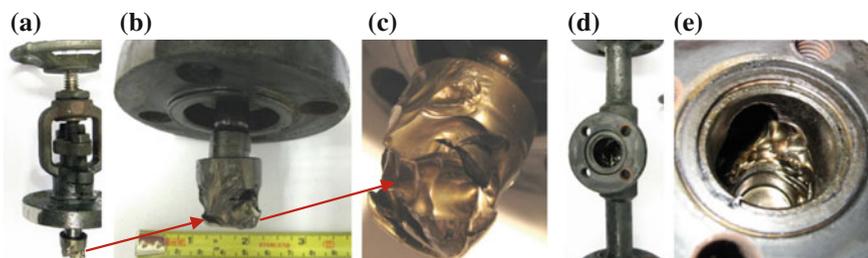
Fig. 6.13 a–c Erosion of the socket. d, e Erosion of inner surface of the valve

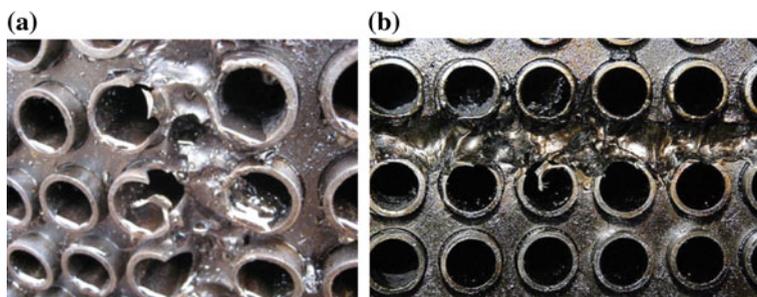
Fig. 6.14 a, b Eroded tube-sheet (after cleaning from deposits)

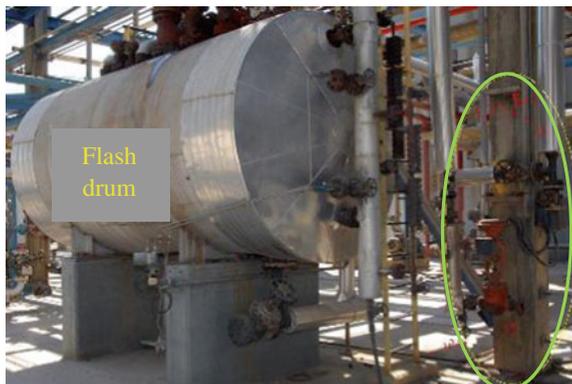
Fig. 6.16 The flash drum and failed pipes area after the controller

Conditions. Water condensate (drain of the boiler drum) mixed with steam flowed in the pipeline. The pressure in the line dropped from 130 bar (before the controller) to 14 bar (after the controller) at 130 °C. The flange was welded to the pipe of smaller diameter (Fig. 6.16).
