Topics in Safety, Risk, Reliability and Quality

Alec Groysman

Corrosion Problems and Solutions in Oil Refining and Petrochemical Industry

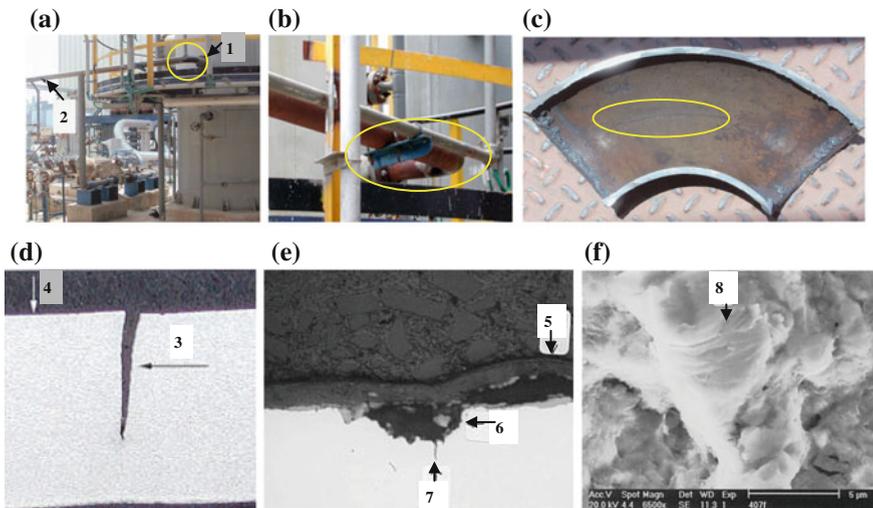
Fig. 6.19 a General view of failed pipe at the HDS unit: 1 location of failed bend, 2 the pipe. b Magnification of the failure area (pipe bend). c The inside of the bend with crack. d Macroscopic cross-section of the bend through the crack: 3 crack, 4 inner surface of the pipe. e Microscopic cross-section ($\times 200$): 5 corrosion products, 6 pit, 7 crack. f SEM photo of the picture e ($\times 6500$): 8 fatigue lines

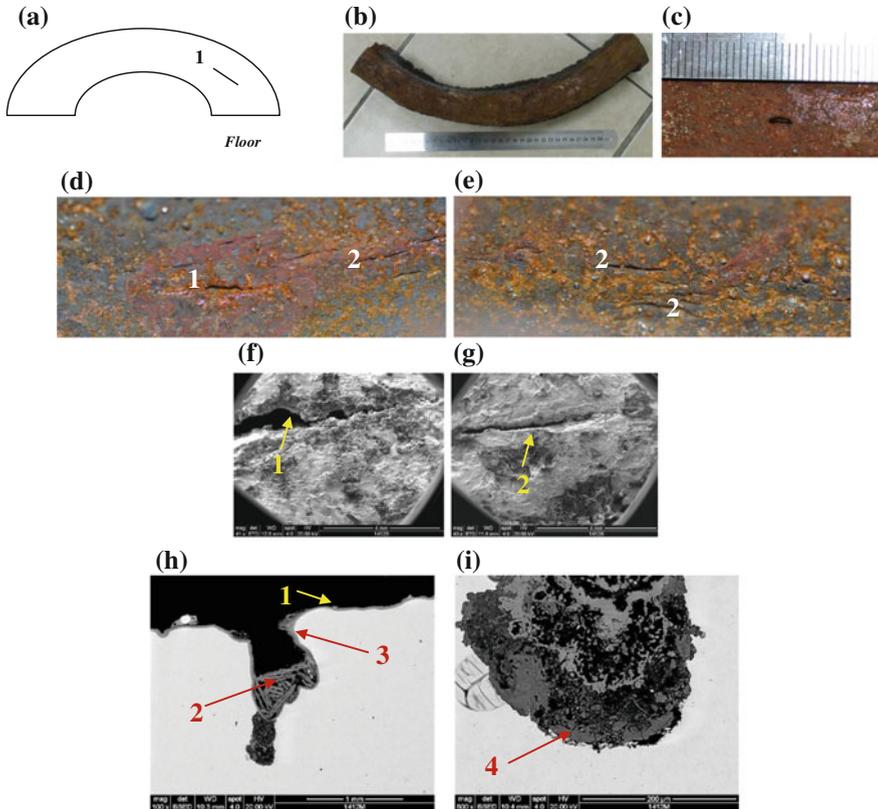
Fig. 6.20 **a** The sketch of the tube with the location of the hole (*1*). **b** General view of the tube with the hole. **c** Magnification of **b** at the location of the hole (outer side). Inner surface of the tube. **d** The side of the hole. **e** The opposite side. *1* the hole; *2* cracks. The SEM photo of outer surface of the tube. **f** The location of the hole (*1*). **g** The crack close to the hole (*2*). Metallographic cross-section through the defect (SEM images) of outer surface of the tube. **h** The pit. **i** The edge of the pit. *1* inner surface of the tube; *2* the pit; *3* oxide layer; *4* corrosion products at the edge of the pit

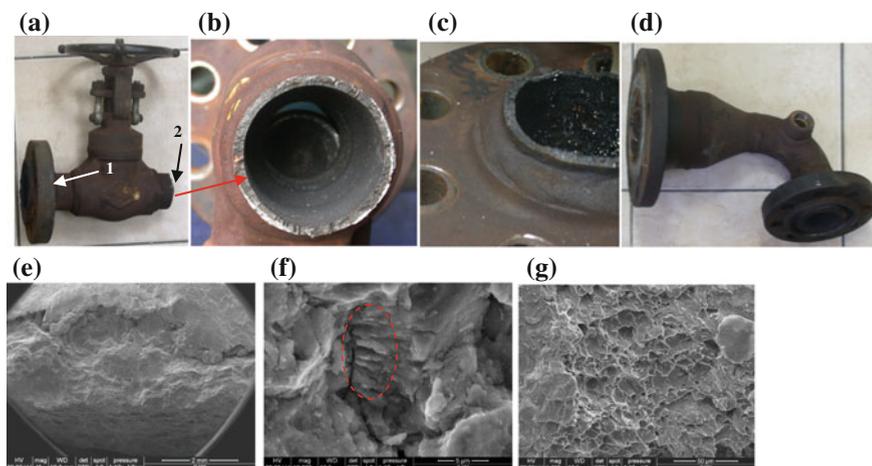
Fig. 6.21 a Failed part of the flange with pipe: 1 flange. 2 fracture of the pipe. b Enlargement of the fracture surface 2 on the picture a. c Enlargement of the fracture surface on the other side (near the welding flange). d The adjacent part to the flange (1). e–g SEM photo of the fracture of different magnifications. The dashed red circle—fatigue striations. g Dimples characterizing ductile fracture

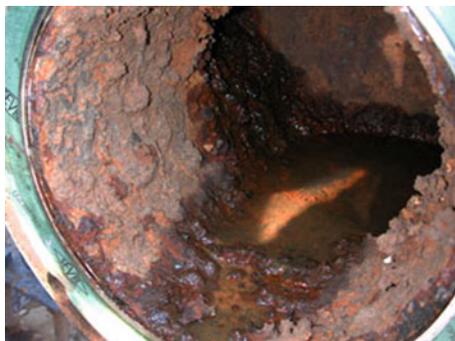
Fig. 7.3 Biofouling created by iron-oxidizing microorganisms

Ageing is a phenomenon when deposits become more cohesive and harden their structure. Ageing may increase the strength of the deposit by polymerization, re-crystallization, and de-hydration [17]. For instance, biofouling where iron-oxidizing microorganisms take part in the process, may be hardened by the presence of ferric ions (Fe^{3+}) and creation of solid shell composed from ferric

hydroxides (FeOOH) strongly adherent to metal surface (Fig. 7.3). Every fouling is subjected to ageing.

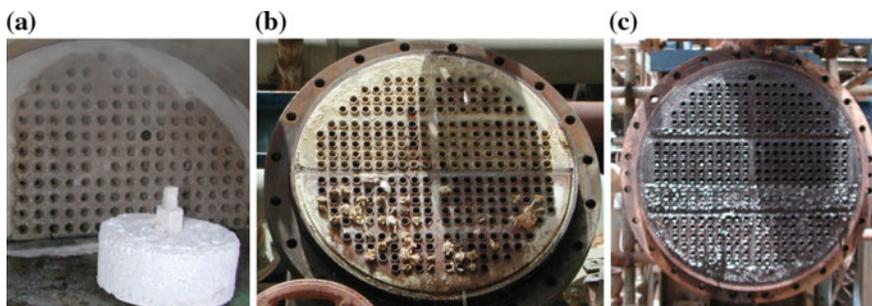
Fig. 7.5 Three years of service. a Blockage of inner space of Ti Gr.2 tubes at crude distillation unit. Inside of the tubes—cooling water ($30\text{--}35\text{ }^{\circ}\text{C}$); outside—hydrocarbons ($120\text{ }^{\circ}\text{C}$). Deposits contain phosphates and sulfates of calcium and zinc ($T > 80\text{ }^{\circ}\text{C}$). b Inside Naval brass tubes—cooling water ($30\text{--}35\text{ }^{\circ}\text{C}$); outside—LVGO ($120\text{ }^{\circ}\text{C}$). Clogging by debris because of bad water filtration. c Inside of carbon steel tubes—‘tempered water’ ($\sim 50\text{ }^{\circ}\text{C}$); outside—LVGO ($120\text{ }^{\circ}\text{C}$). The tubes are clogging by *black* polymeric substances forming as a result of penetration of LVGO into ‘tempered water’

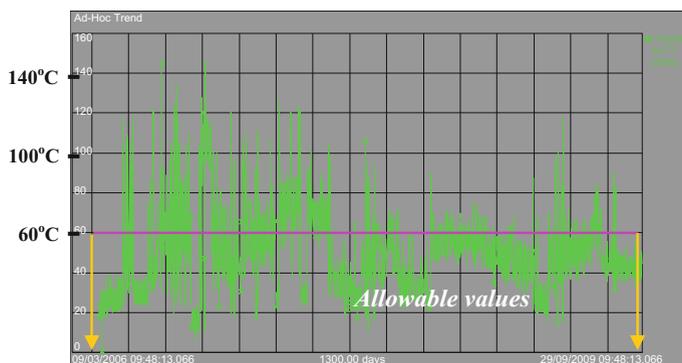
Fig. 7.7 Temperature fluctuations of LPG at the inlet to the heat exchanger during 3 years, PI data

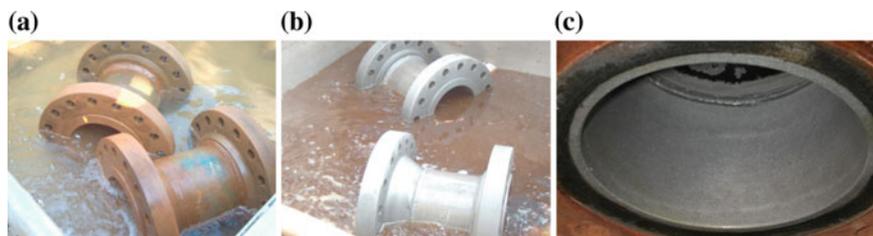
Fig. 7.9 **a** Rusted control metal parts before cleaning and passivation. **b** The same parts after the passivation. **c** Visual examination (inspection) of inner surface of the pipe (its end) after cleaning and passivation (well formed passive oxide Fe_3O_4 layer of grey color is formed)

After finishing of chemical cleaning, system is drained, flushed with water, neutralized, and passivated (if required). The effectiveness of cleaning and passivation may be evaluated according to control metal parts which are immersed in solutions (in bath) which are used during all stages of cleaning (Fig. 7.9). In the case of unsatisfactory cleaning of the equipment, the cleaning procedure should be repeated. Solutions after draining should be disposed at appropriate facilities with the permission of ecological department and local authorities (if required)

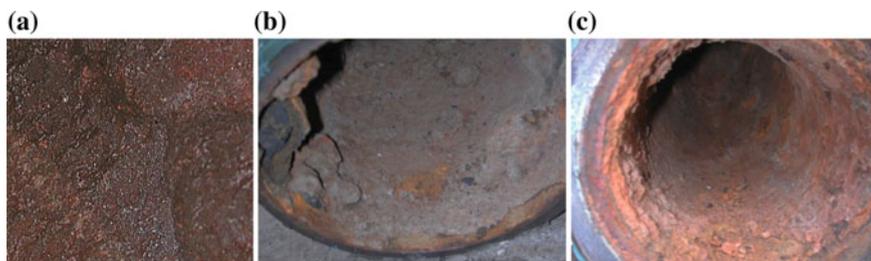
Fig. 7.10 a, b Biofouling (slime and rusted tubercles) in cooling water system after 4 years of service (before complex biocide treatment). c Inner surface after treatment with NaOCl, biodispersant and organic biocide

Some notes about correct decisions. It is important to make the right decision regarding the chemical cleaning with acidic solution of inner surface of large carbon steel pipes (diameter 100 mm and more) containing 'heavy' corrosion products accumulated inside (Fig. 7.10).

Generally these corrosion products represent rusted tubercles (formed as a result of the activity of iron bacteria) with severe underneath localized corrosion which can penetrate through whole wall thickness of the pipe. Thus, chemical cleaning by acidic solutions can dissolve rusted tubercles and uncover corrosion through-holes

in pipes. This situation may cause perforation of piping and unexpected leaks of acidic solution ($\text{pH} \sim 2.8!$) representing a hazard to working personal and corrosion risk to nearby equipment. When severe corrosion with rusted tubercles are revealed inside piping, it is not recommended to clean inner surface of such pipes but completely to replace them. Unfortunately, not always there is economic justification to renovate such system immediately, and refinery should remain with this pipes for several years. For instance, refinery is planning to replace cooling towers in 2–3 years. In this case, it is possible to avoid acid cleaning because of possible perforation and to apply treatment with mixture of NaOCl, biodispersant and organic biocide. After several days of such treatment, rust becomes more dense, and this piping can be used for several years (see Fig. 7.10c).

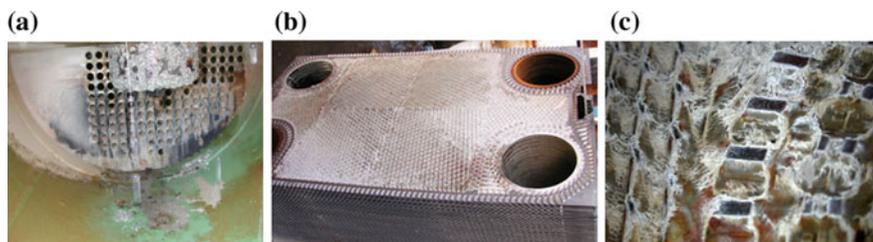
Fig. 8.5 Clogged heat exchanger (cooling water-side) with titanium tubes (Ti Gr.2) after 4 years of service (a), and titanium plates (Ti Gr.1) after 1 year of service (b, c). White-grey deposits: calcium phosphate, zinc phosphates, and calcium sulfates. $T = 30\text{--}35\text{ }^{\circ}\text{C}$. $P = 4\text{--}5\text{ bar}$. (The picture c is the magnification of the picture b)

One of serious problems is a formation of fouling(scale and deposits) on titanium tubes, tube-sheets and plates in heat exchangers from cooling water-side (Figs. 8.4, 8.5). Usually this is similar to the formation of scale and deposits on other materials with passive films, such as stainless steel and copper alloy heat exchange surface (see Sect. 7.4).

If cooling water is treated by corrosion inhibitors (zinc-phosphate-phosphonate), deposits can contain calcium and zinc phosphates and calcium sulfates, and can even clog the inner surface of titanium tubes after 4 years of service (see Fig. 8.5a). Plate heat exchangers (because of close position of plates) can be clogged even after a year of service (see Fig. 8.5b, c). Sometimes corrosion products (iron hydroxides/oxides) may be present in deposits. Carbonates, sulfates, phosphates and hydroxides have different solubility in cleaning acid solutions.

Slow water velocity and absence of sufficient concentration of anti-scaling agent in cooling water results in the precipitation of deposits. In order to diminish and prevent fouling, the following solutions and recommendations should be carried out:
