### DESCRIPTION

A night shift production operator died when he fell into the sea through a rusty grating on the platform. His body was never recovered. Less than 24 hours prior to the incident, a single section of severely corroded and deteriorated grating, posing a walking and working surface hazard, was identified on the north side of the well bay by a supervisor, who said that the grating section felt “spongy” underfoot. Upon examination, he found that bearing bars at one end of the grating section had deteriorated.

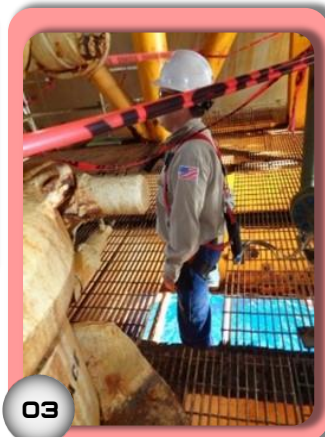
02

Post-Incident photograph of hazardous grating section suspended in open hole

- Ensure crew are informed about all identified hazards in a timely and meaningful way;
- When hazards are identified, fix them;
- Better understanding of and agreement between, operators and contractors in terms of safety management systems bridging arrangements.
