DESCRIPTION

HARNESSES SUSPENSION TRAUMA

BODY MALFUNCTIONS AFTER A FALL ARREST

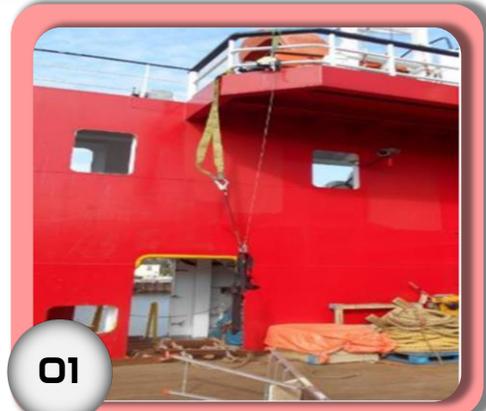
01

Incident location, with harness hanging from belt, and fall arrestor connected for retrieval, as demonstration of the situation at the time of the incident. The fallen ladder was part of the drill scenario.

When suspended in the harness, the straps around the legs and limbs may have obstructed the blood flow, as indicated in the graphics on the following page, which is commonly known as suspension trauma.

- Performing drills and exercises to a realistic scenario is essential to ensure the crew can act promptly and effectively in emergency situations. However, the risks of such exercise shall always be carefully assessed.
- The risk of trauma from being suspended in a harness can be effectively reduced by using suspension trauma relief straps after falling into the harness, this places the weight of the body on the feet while awaiting rescue.

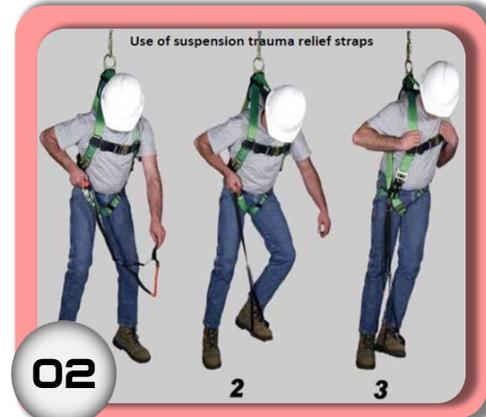
02

Use of suspension trauma relief straps
