DESCRIPTION

An electrician installed fuses on a 930V DC electrical system while the system was live. Under deck carousels were mechanically and electrically isolated as a precaution for maintenance work. Several other important vessel systems were powered from the same drive cabinet. The electrical isolation was conducted by removing the fuses for the carousel drive unit.

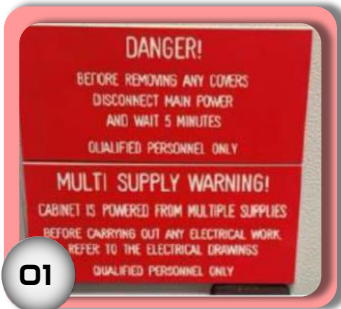
Signage on Cabinet Door

- Additional work team requirements with regard to the isolations had been discussed in the Toolbox Talk (TBT) but were not carried out;
- The electrician re-installing the fuses did not check if the power to the drive cabinet was isolated before starting work – failing to follow the instructions written on the cabinet and the work instructions given him.

- Review of procedures, work instructions, task risk assessments etc. with regard to Permit to Work and electrical isolations;
- Review of Toolbox Talks to ensure they cover all aspects of the work including PTW and isolations;
- Check that the system you are going to work on is **isolated** – **BEFORE** you start work;
- Follow the instructions and warnings signs posted in the workplace. If in doubt, ask!

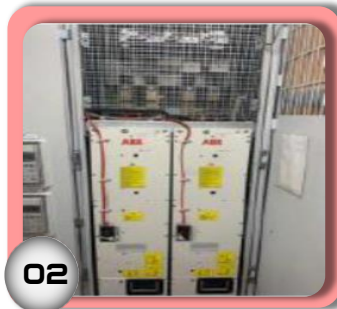
Open Cabinet with Fuses on Top

- Procedures were not followed: the security of the electrical cabinet was not in accordance with company procedures; the electrician did not lock and tag the cabinet while the fuses were removed;

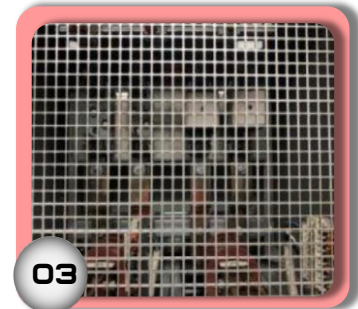
Fuses Behind Protective mesh
