# National Transportation Safety Board

## Marine Accident Brief

### Overtuning of the Liftboat *Kristin Faye*

<b>Accident type</b>	Other	<b>No.</b> DCA19FM050
<b>Vessel name</b>	<i>Kristin Faye</i>	
<b>Location</b>	Gulf of Mexico, Main Pass Block 64, about 18 miles east of Venice, Louisiana 29°18.10' N, 89°03.30 W	
<b>Date</b>	September 8, 2019	
<b>Time</b>	1015 central daylight time (coordinated universal time – 5 hours)	
<b>Injuries</b>	1 minor	
<b>Property damage</b>	\$750,000 est.	
<b>Environmental damage</b>	120 gallons of diesel fuel released (sheen 3 miles x 67 feet)	
<b>Weather</b>	Visibility 10 miles, cloudy, winds northwest at 6-7 knots, seas northwest 1-2 feet, air temperature 85°F, water temperature 82°F	
<b>Waterway information</b>	The Main Pass lease area of the Gulf of Mexico lies northeast of the Pass A Loutre entrance to the Mississippi River and abuts the Louisiana coastline.

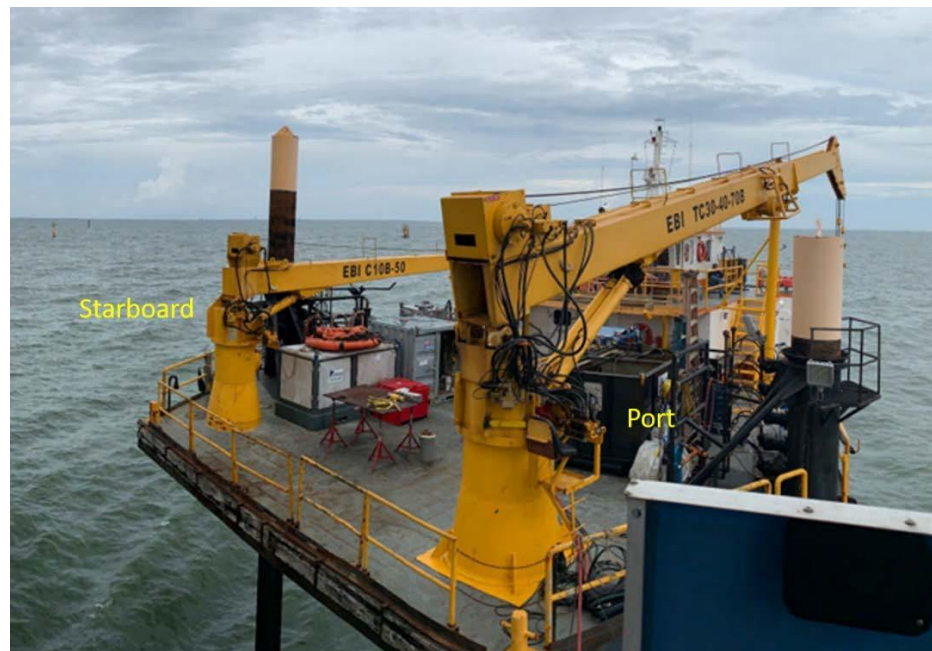
The liftboat *Kristin Faye* in an elevated position alongside *Platform AQ* before the accident. (Source: Sanare Energy Partners, LLC)
